# **MOUNT WASHINGTON STATE PARK**

TIP-TOP A HOUSE HISTORIC SITE () ADAMS SUMMIT BUILDING & SNACK BAR \$

#### **Draft Assessment Presentation**

March 14, 2025

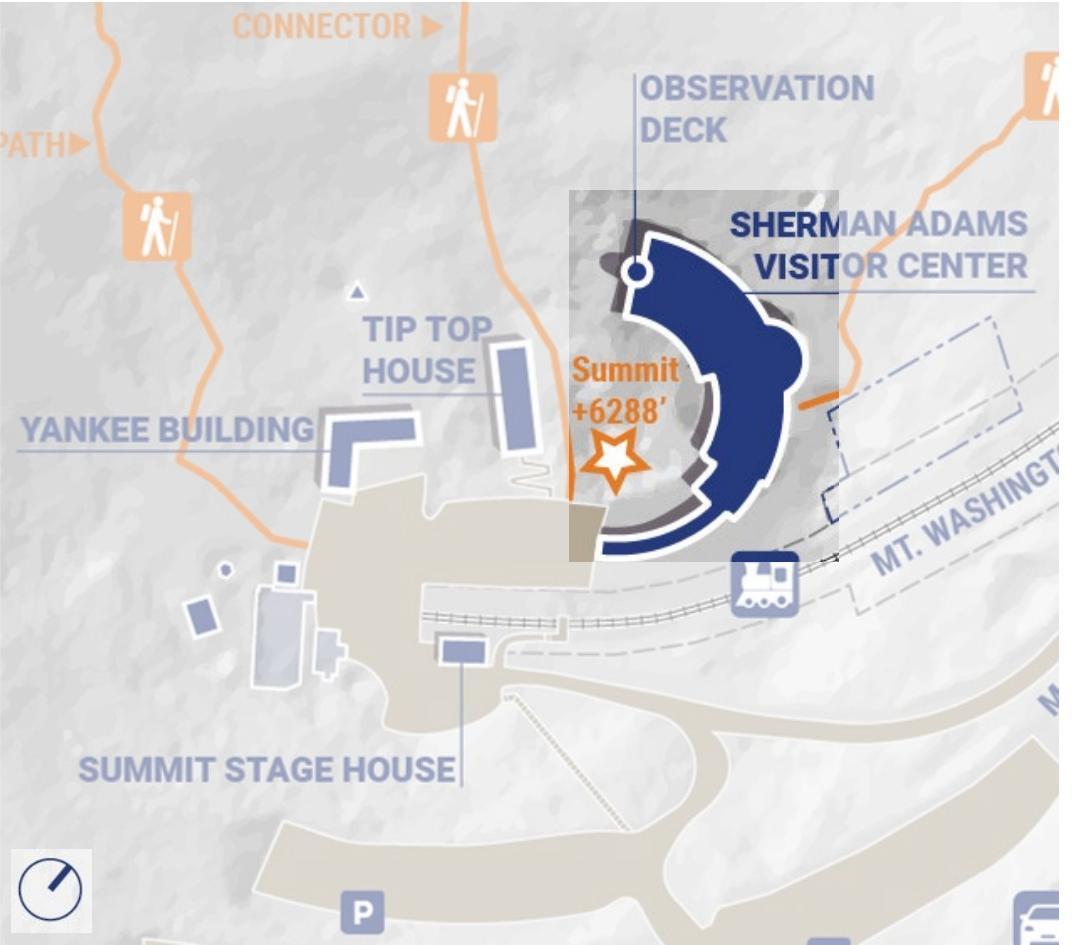
### DRAFT BUILDING ASSESSMENT Sherman Adams Building

#### • Roof leaks

- Deteriorated chimneys
- Uneven roof pavers
- $\circ~$  Leaking door at observation tower
- Windows on lower level in poor condition
- Spalled façade concrete
