Terrill Pond Dam-October, 2014

Terrill Pond

Dam Safety Deficiencies found in 2009 during a routine inspection

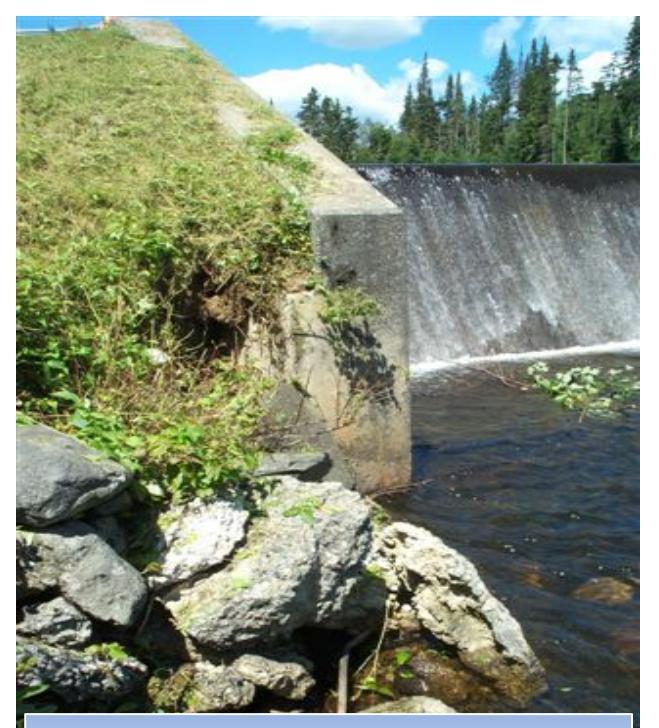
Piping and erosion on right abutment

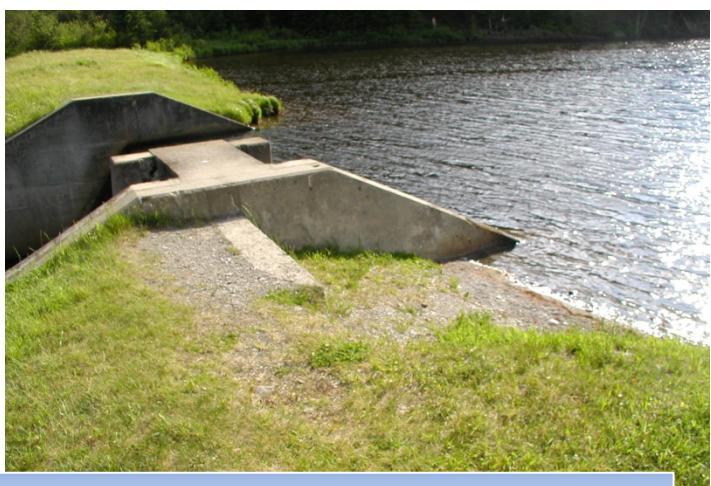
Eroded crest and exposed cutoff wall

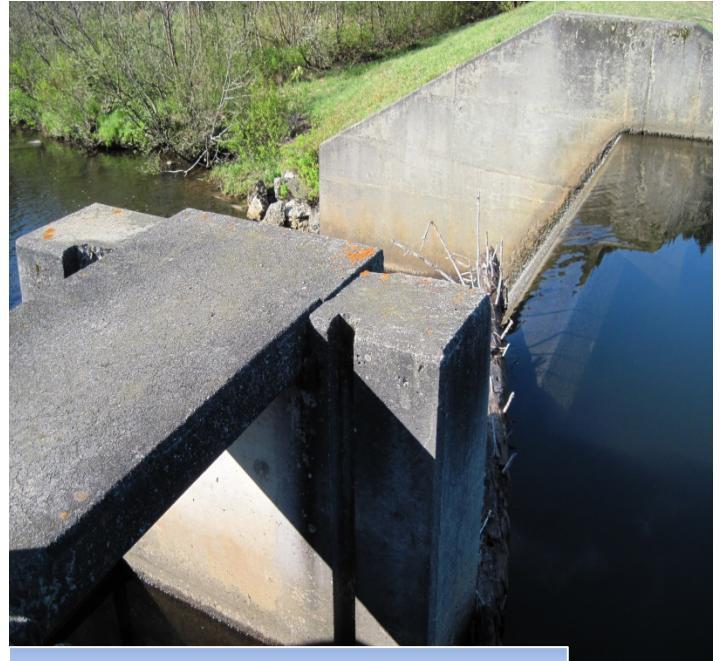
Displaced stop log bay slab -4"

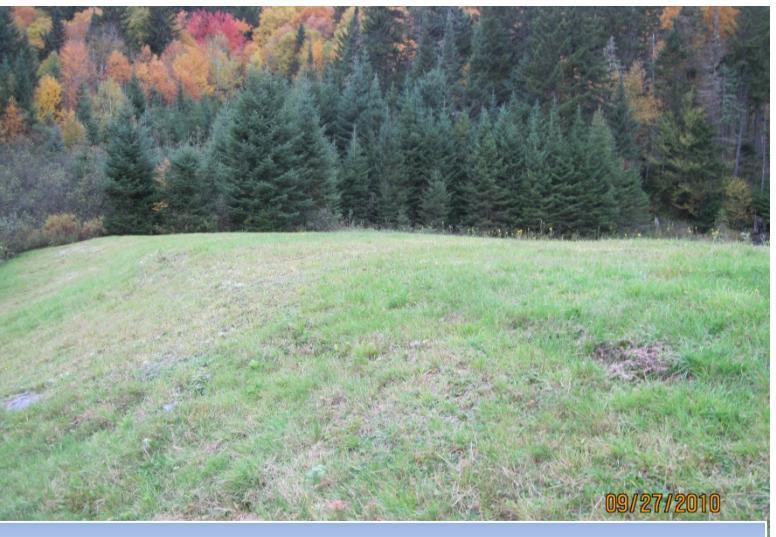
Sinkholes and wet areas on right embankment

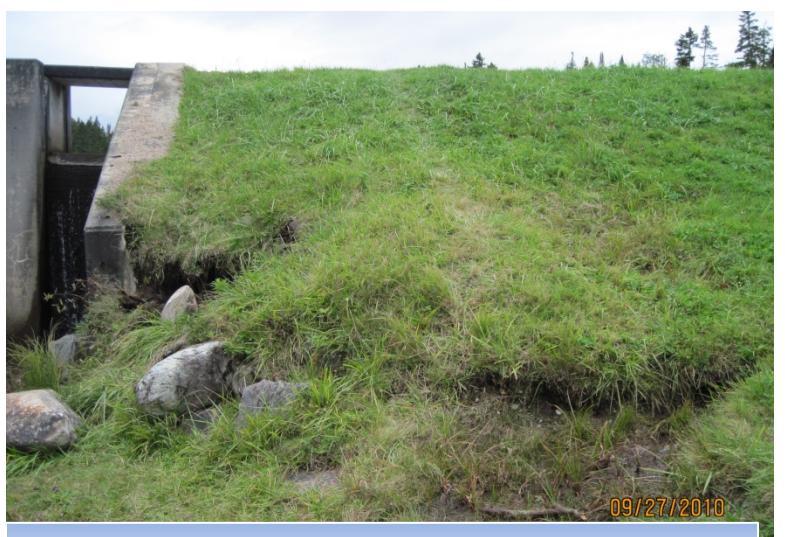
Evidence of piping on left embankment

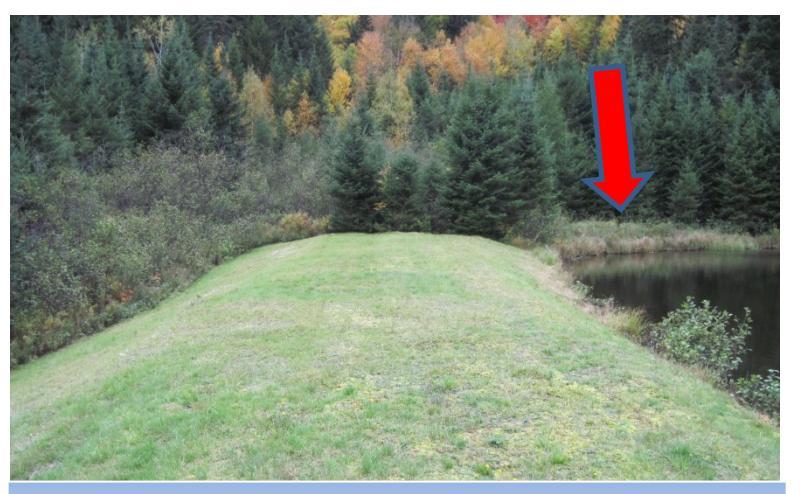
Trees and brush within 15 feet of end of dam Auxiliary spillway overgrown with trees

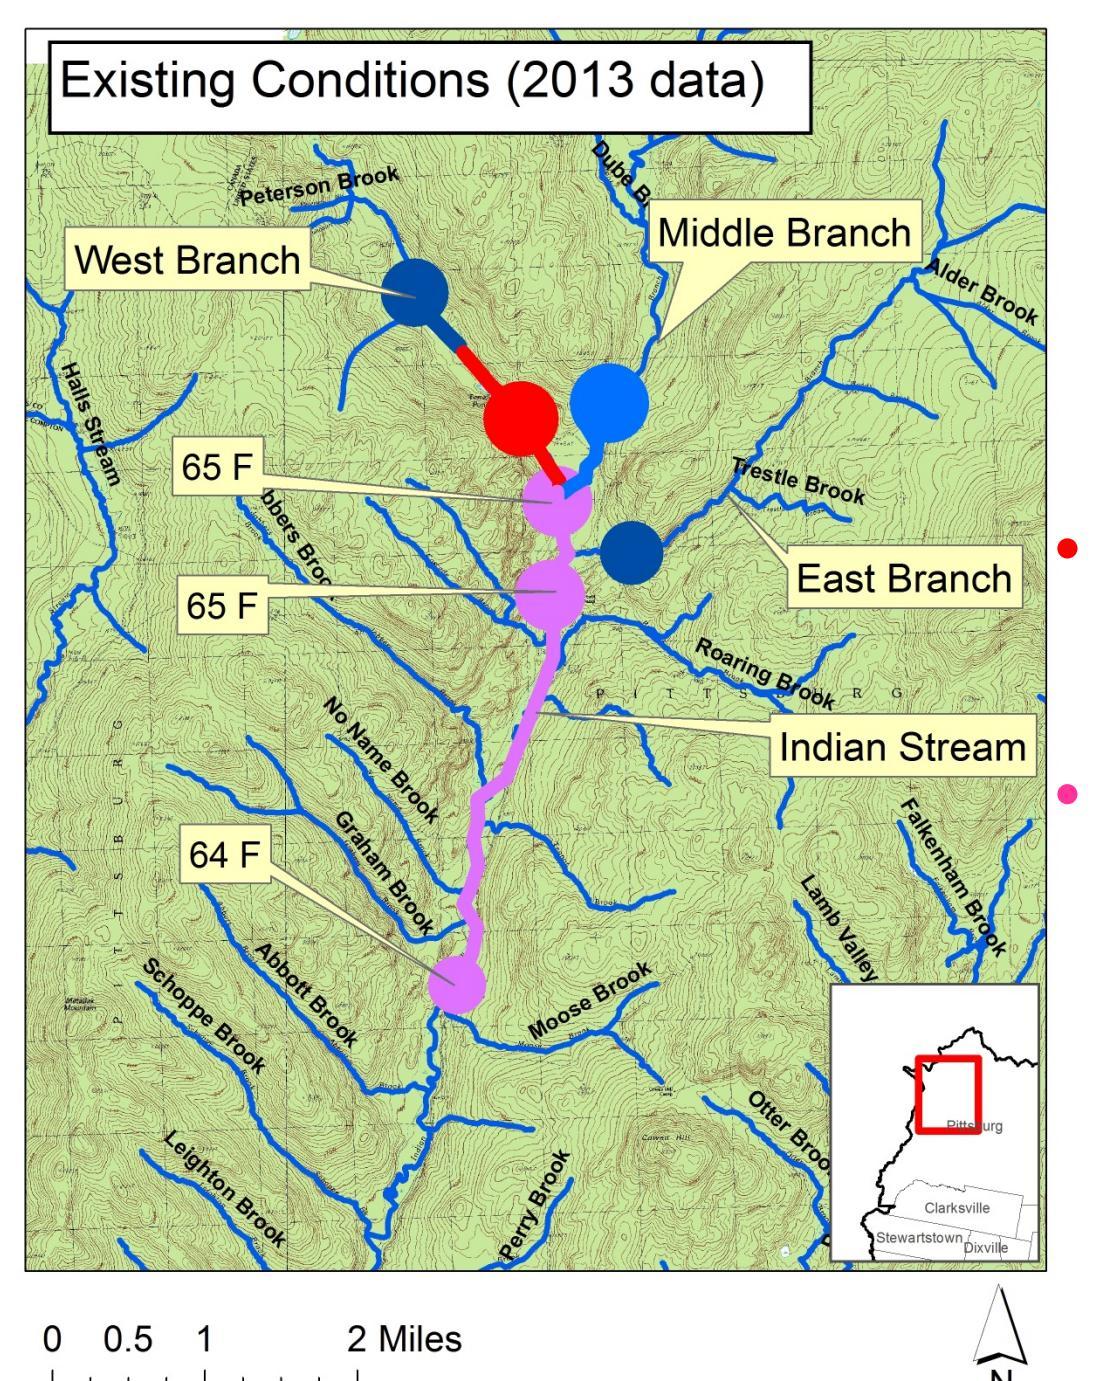
Water Temperature

Red area surpasses 70 F° =Low trout catch rates

Pink area = lowered trout abundance

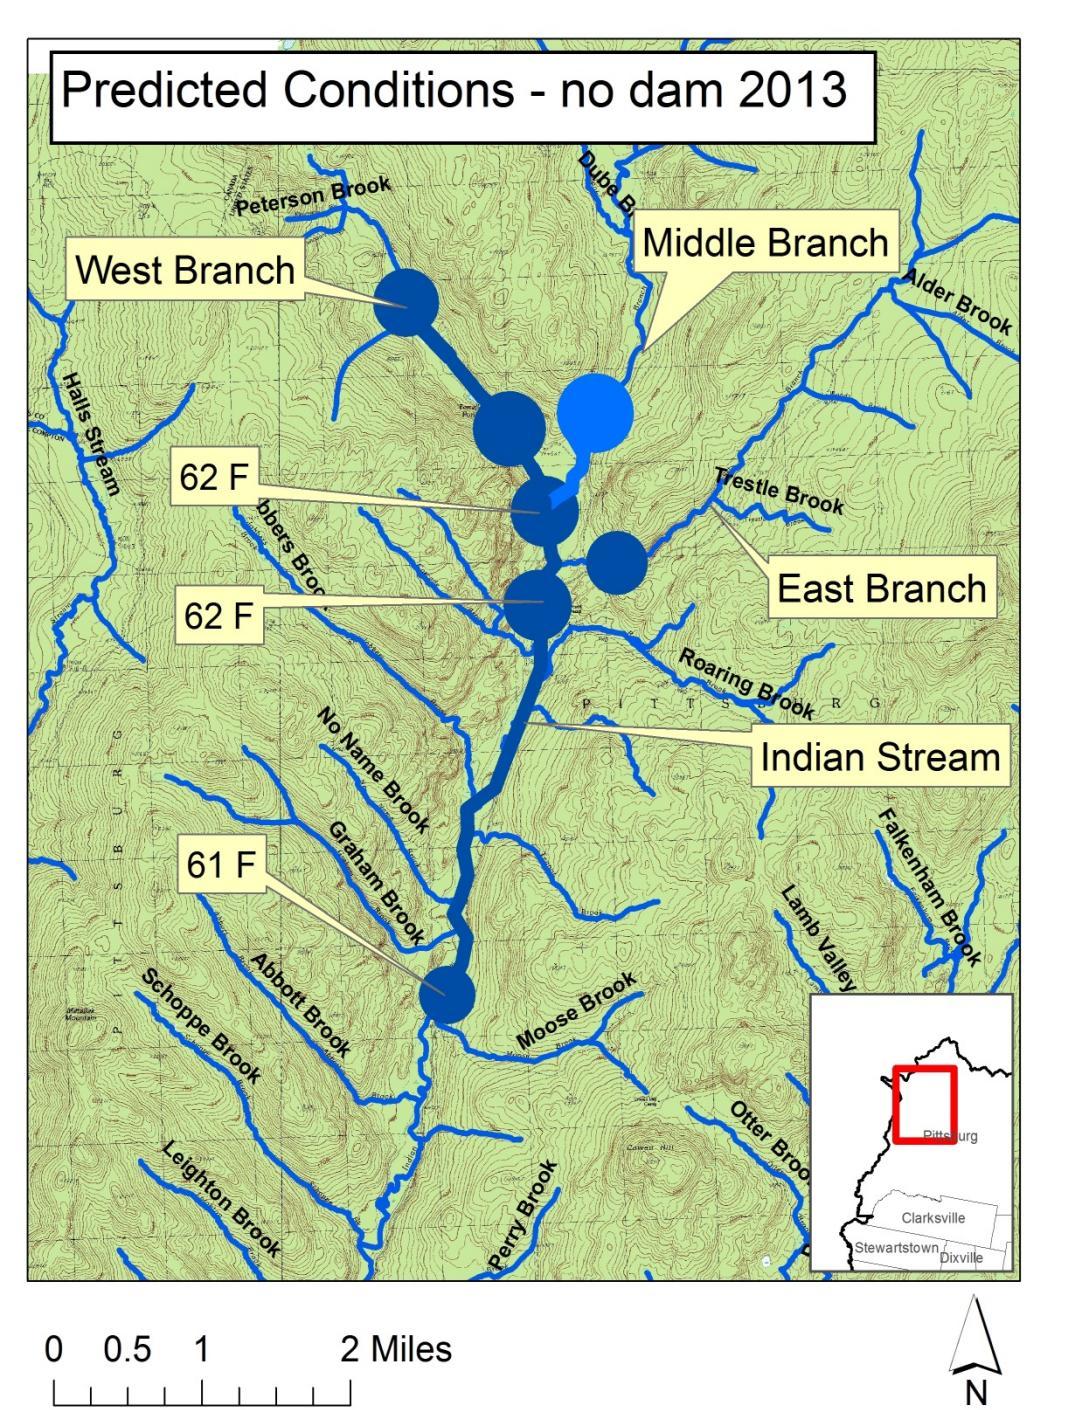
- Temperature Model without dam
- Blue indicates favorable water temperatures for trout
