## Trip Report 080825 – Bear Brook and Pawtuckaway

### Trip Report 080715 – Ahern and Ellacoya

### **Trip Report – 081006 Bear Brook/Kingston Loop**

### **Trip Report – 080911 Greenfield State Park**

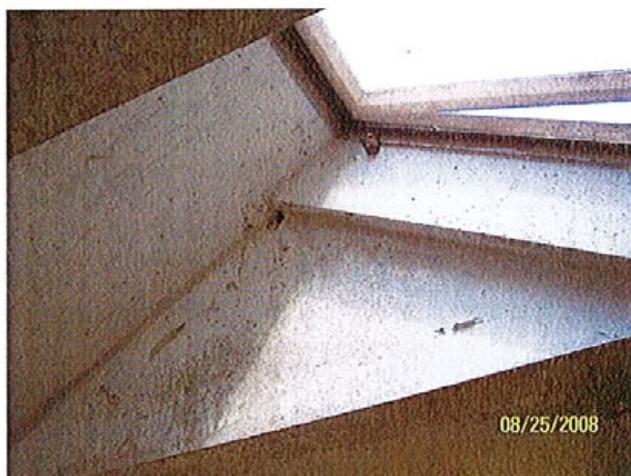
remaining buildings. I did observe a great deal of mold in the shower area of the bathroom building, so moisture is not being properly controlled.

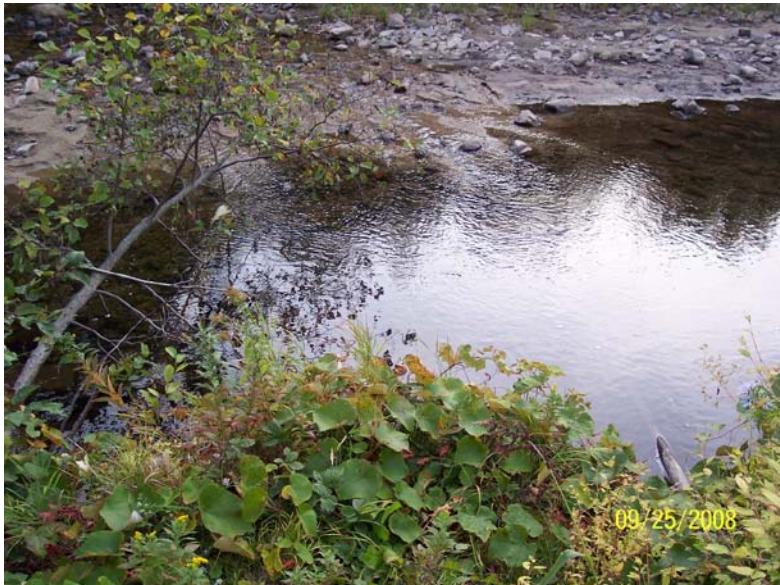
**Docking:** Once the watercraft are deployed there is no dock or moorings for tying up. They generally pull up on the sand and tie to a tree. There is a 3' high wall along the shoreline from the boat ramp area towards the beach, probably 100' long. Watercraft using anchors and random ties to trees are a potential safety problem; when at night particularly, someone could trip on the ropes, fall on the concrete and into the water. Kevin indicated that Chris could install 4X4 posts with ring hardware directly behind the concrete for tying up. This would eliminate the ropes on the ground.

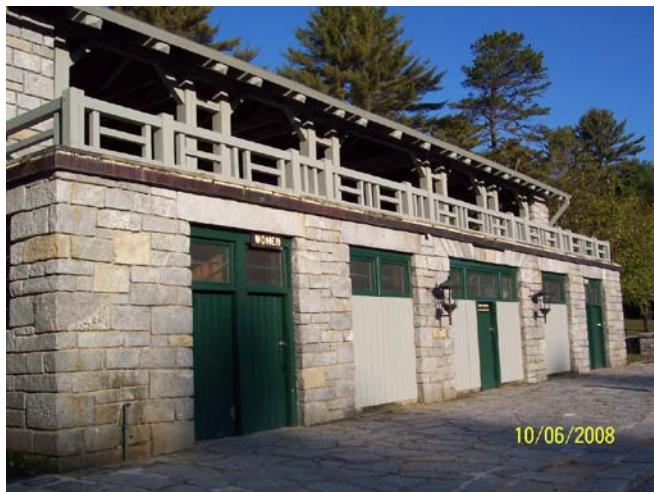
Manager Gregg Preville and I walked in from the toll booth. The parking area showed no signs of problems, gravel, flat and sized to accommodate the day use activity. We walked the grounds by Catamount Pond and observed the rehabilitation work to the old granite pavilion/bathhouse. Granite masonry had been repaired, ADA ramps constructed, and roof leaders installed. Unfortunately the under drains tied to the roof leaders were poorly designed and eroded the beach in several locations.

The roof over the toilets/changing rooms, which is the floor to the pavilion above, leaks. Gregg believes the rubber membrane under the concrete tile floor has been damaged and needs to be replaced. The septic is captured in a tank and pumped to a leach field up by the parking lot.

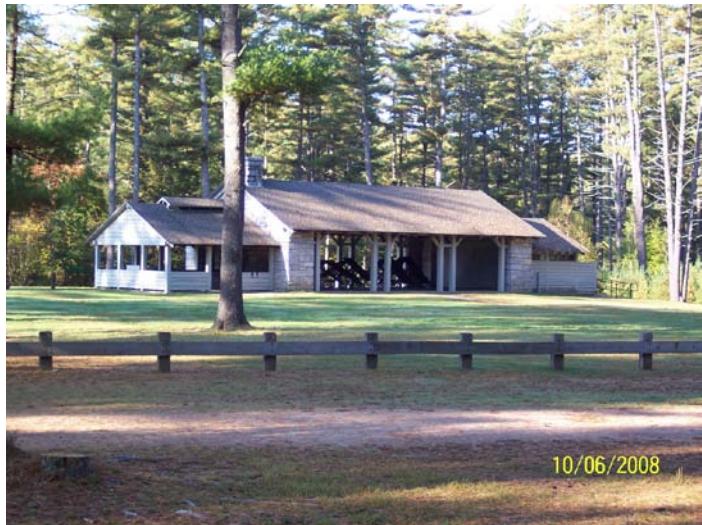
Across the brook on the right is the group shelter, a baseball field and an unused BBQ house. Old pine logs are used to delineate access roads and should be replaced with timber fencing. The trail down to the ball field needs maintenance as it is fairly steep and uneven under foot traversing the exposed tree roots. The backstop ..... The old BBQ house is being used to house the lawnmower used around this area of the park. While this whole area could be expanded with another pavilion, it is essentially a picnic

shelter area for a single group to rent and have use of the toilets, field and parking with some privacy. I would remove the BBQ house and fireplace and construct a shed for the tractor nearby.

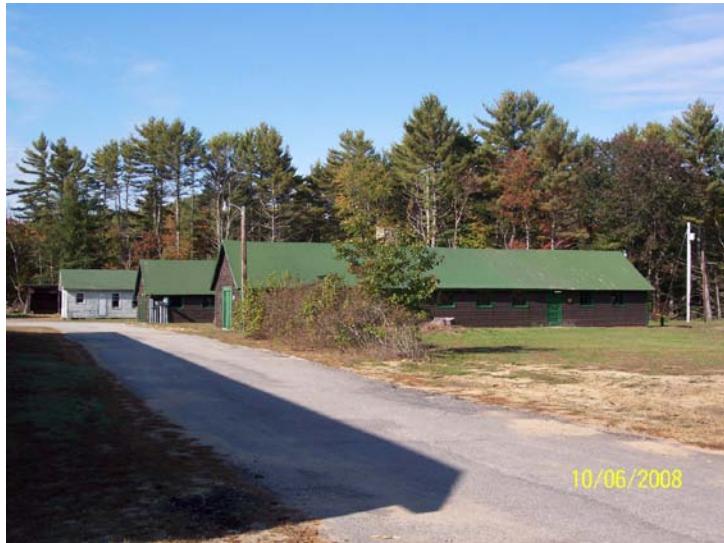
The group area across the street includes an old family toilet, and old picnic shelter and another baseball field to the rear. This area is hardly used and Gregg would like to convert it to group camping. There is a make-shift fence between the top of the slope about the pond that ought to be replaced with a substantial chain link. A few trees removed would make way for tent sites and the area is appropriate for group camping.

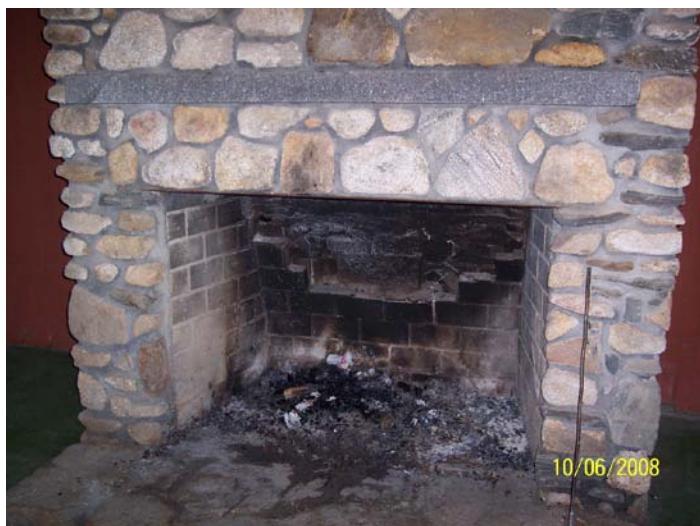
The group picnic area pavilion has damage to the firebrick in the fireplace and should be repaired by a professional mason. This pavilion also definitely needs a barbecue pit. The toilet building is adjacent. There is standing water by the swing set and pathway into the group area that could easily be removed with some simple drainage appurtenances.

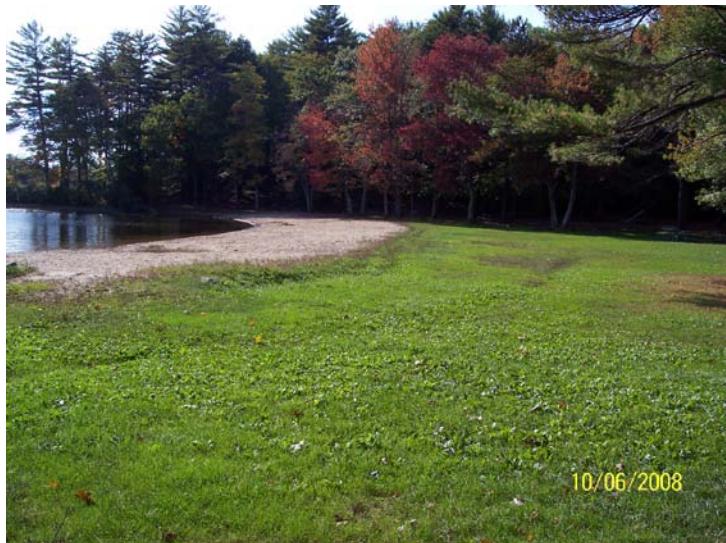
Kingston State Park is similar to Silver Lake and provides the local citizenry 44 acres for swimming and picnicking. Two bathhouses with dressing rooms and flush toilets are available. The paved driveway into the beach parking lot which holds about 110 vehicles on a gravel lot is in good condition. The beach sand appears to have been imported and it is higher than the adjacent ground, causing water to stand to the rear or wash

through to the lake leaving channels. There are a lot of leaves on the bottom that you don't expect at a state beach.

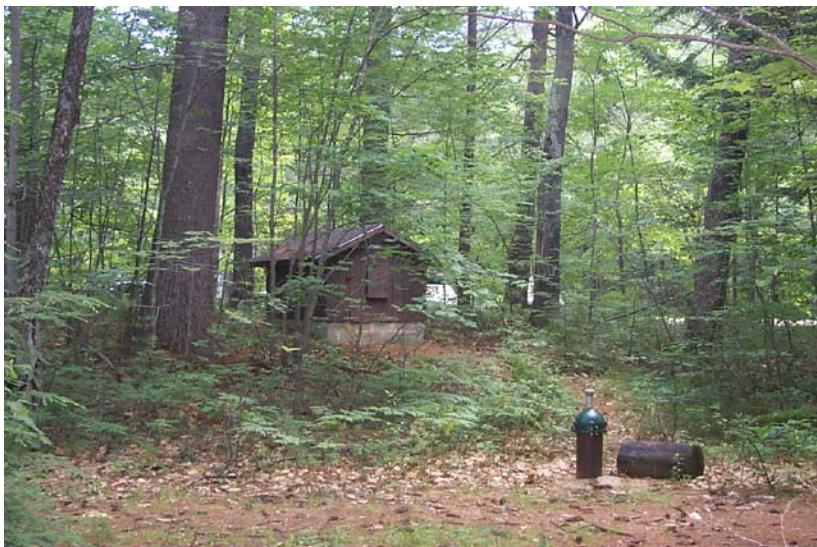
Toilet building appears good. Water pipe exhibits rust and corrosion, especially upon seasonal startup. Observation: Pipe from well to toilet building should be replaced.

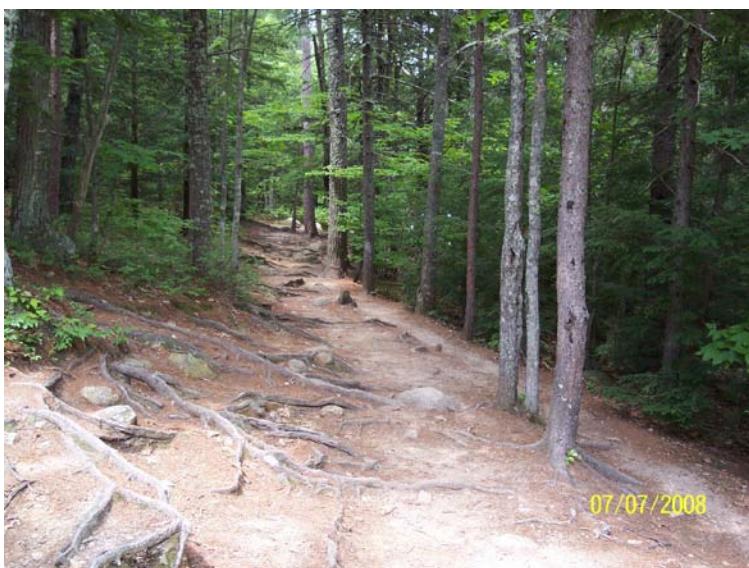
Top of Cathedral Ledge. Needs designated and ADA pathway to scenic overlook. Handicapped access up and back on a 1:12 ramp would be acceptable, however able bodied visitors could be shown a designated route on the rock to be able to loop the top and take in the views to the east and south, returning to the parking lot via another designated exit route.

Observation: This is a very desirable scenic overlook that should be run as an auto road with a fee. It needs the improvements discussed. Engineering and landscape design should be intricate in its detail. There needs to be an emphasis on safety barriers for the protection of visitors, and no access after dusk or a certain time.

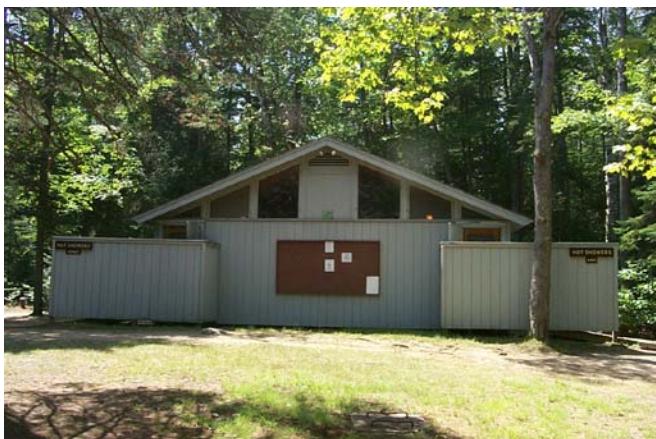
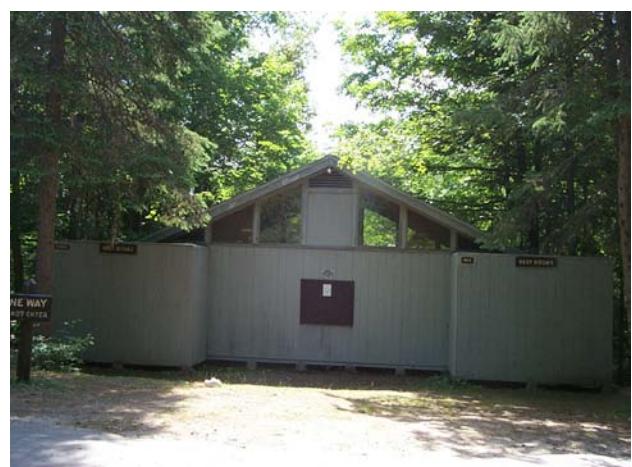
Toilet/shower facilities.

Observation: Need data on age of toilet/shower buildings, need improvement for true ADA, shower room tacked on really not appropriate for use.

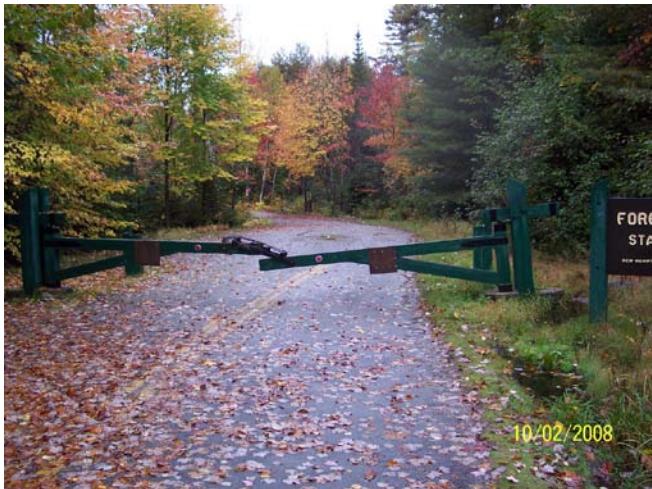
The water has undermined the gate and there is not the standard park sign on the pole out front. A new entrance needs to be designed and constructed, which might include new pavement over the excising surface treated gravel that constitutes the driveway to the parking lot. The parking lot has paved drive lanes but the parking spaces are on gravel. Some vandalism occurs, as in vehicles pushing on the gate across the service road, etc. Snowmobiles running up and down the timber

stairs at the beach do damage. Staff is just part-time to open gate, clean restrooms and trash, and later close gate. I don't think toll booth is manned.

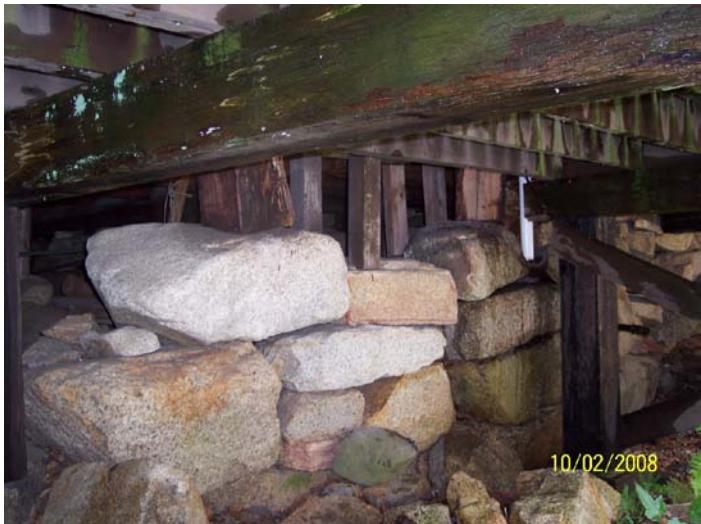
building), and provides access to numerous hiking trails, waterfalls, fishing, wildlife viewing, and spectacular mountain views. See previous report for details. This visit was primarily to reexamine the foundation under the Willey House, composed of piled river rock with 6x6 posts. The frost continues to upset these posts and cause an uneven floor to exist above. Before I would demo and resite this building it would be necessary to see if it

could be jacked. Even providing something more than existing but short of a complete concrete foundation could be possible.

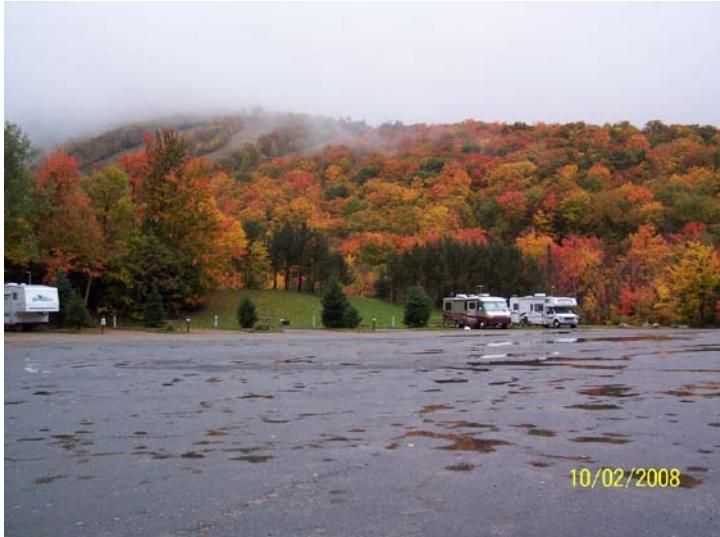
I met with John Ireland (JI) who was in the process of submitting his 2008 annual report to Concord. He continues to cry out for solutions to the road and drainage problems that were antagonized by the heavy rains this year, but that have been evident for several years now. My impression was the gravel was too fine, susceptible to wash, and flows were being concentrated in ditch lines. If the roads were built up to match the old ground water would sheet downhill without concentrating.

There was an old uphill berme ditch that protects the campground from the mountain to the rear that could be cleaned out.

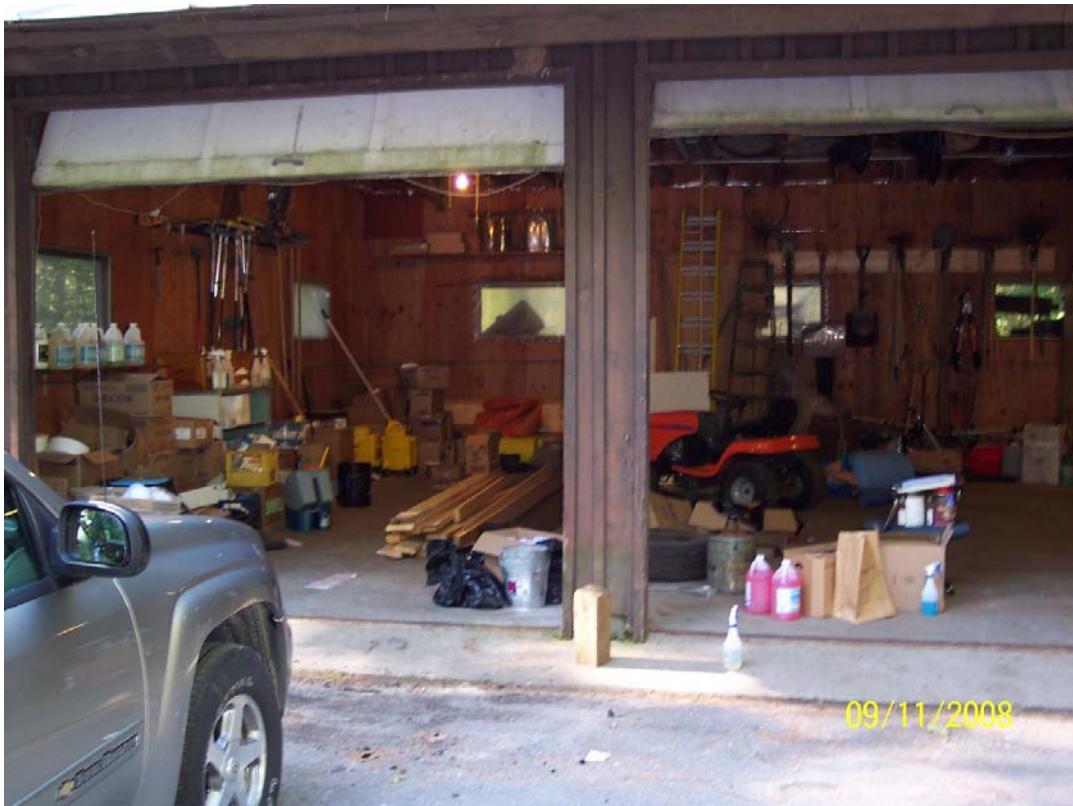
Being that it was the end of the prime season for camping at Greenfield I accepted the fact that the maintenance garage was in disarray. The garage has had air ducts installed from the forced hot air furnace in the workshop, however the insulation, fiberglass batts, are disheveled against the roof and not doing any good. The garage area needs a ceiling strapped on and then insulation applied at that level to prevent heat loss. Materials would have to be fire code. There is asbestos board throughout the workshop that could be damaged and become a health issue. The equipment in the garage (lawnmowers, chainsaws, trimmers, etc.) appeared to be good. Power to maintenance garage is 100 AMP.

The yard was not cared for, the bulkhead leaks; there was moss and debris on the roof. There is also a frayed power wire incoming from the pole that was written up by Mussey years ago.

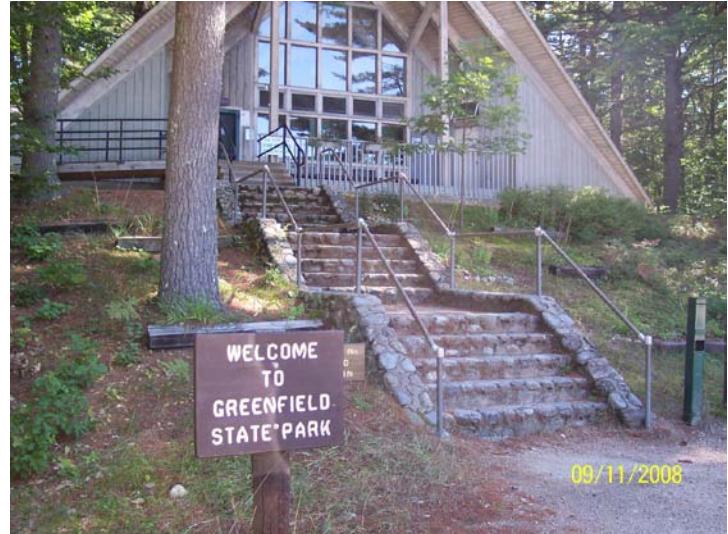
The administration building requires campers to hike up some old mortared stone steps, that while they are in fair condition doesn't really invite people in. The grey stain is scheduled for 2010. Because of the roof design of the A-frame, people have done damage to the shingles by climbing on them.

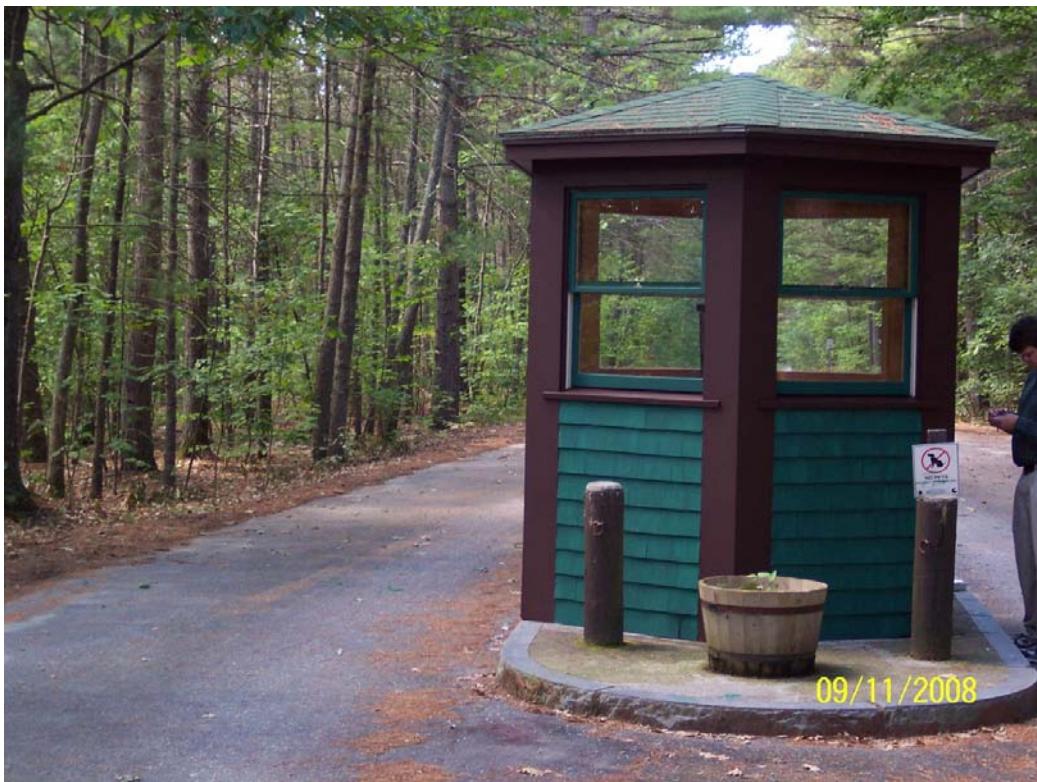
The toll booth was recently stained. No electricity. The wood bollards were rotted.

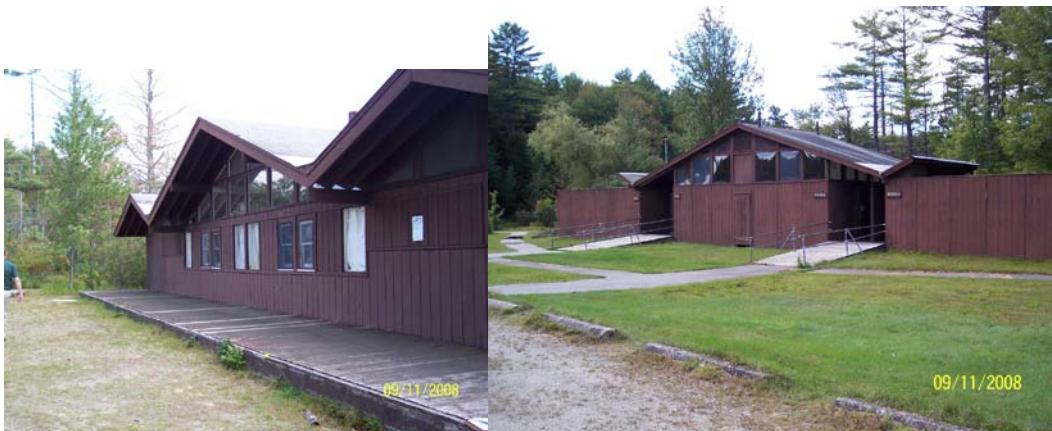
During conversations with Harry and Michelle problems with the bathhouse, day use and store became evident. Rot in the old bathhouse had caused them to remove sections of roof. The sonotube pilings under the floors to the bathhouse and store have shifted and these building ought to be removed and replaced if day use is going to continue. High water in the lake was nearly encircling the bathhouse and store buildings. Michelle felt that culverts at the access road and the railroad were keeping the water from draining, however I inspected the access road twin 48s and found them to be open. Perhaps the

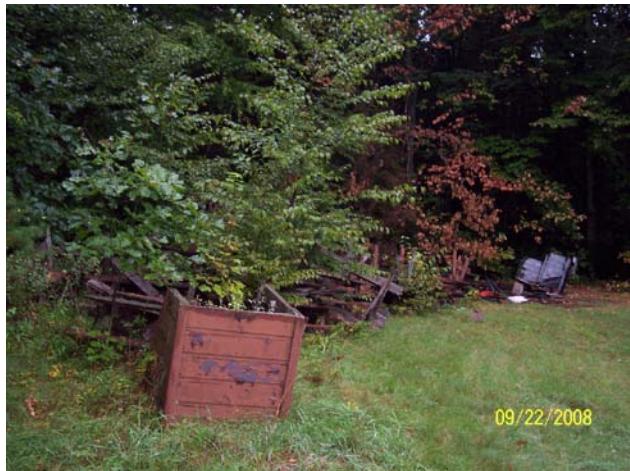
The general appearance begins with a weathered sign at the street. Old picnic tables and debris surround the maintenance garage that should be piled in the parking lot and burned. The water system and/or the sewer system appear to be damaged by the recent high water and may not be useable. The pavements, with the exception of the toll booth area, appear to be in good condition.

The two bathhouses were not inspected inside, but peering into the north building through a vandal's hole in the roof all fixtures appeared to be damaged and broken. There is a \$475,000 budget for 2010-2011 to replace these buildings. The elevation may be driven by the flood control business; however it is difficult to site these building for handicapped use without a special effort. Also, I imagine as part of the building projects that the infrastructure pumps and controls will be replaced.

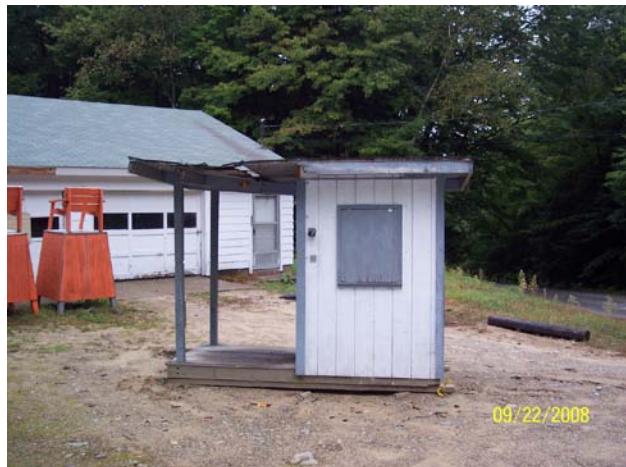
The toll booth is moved spring and fall to and from its location on the road, and this mobility has led to its demise. It will have to be repaired/replaced. The pavement at the toll booth location has been broken by vehicles stopping and starting on the gravel shoulder to pay their day use fee. This pavement should be reconstructed.

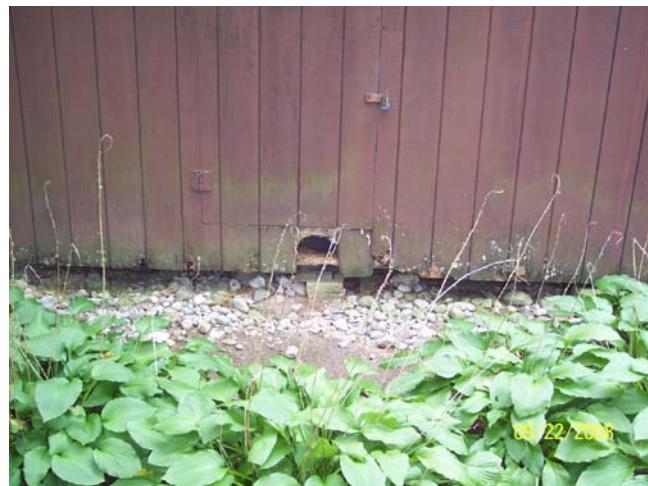
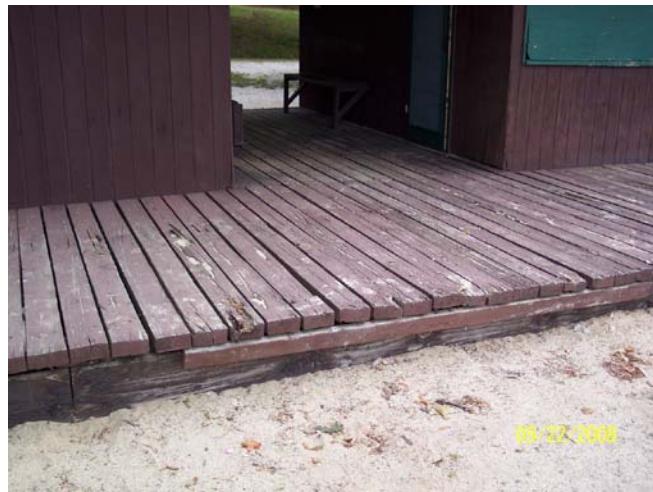
The walkway planking at the bathhouse and the store/office needs to be replaced. There are rodent holes and other pest infestations going on at the bathhouse. The old playground swing set shows plenty of use and that area could be maintained better, as should the horseshoe pits. The 0.3 mile nature trail is an amenity if interpreted.

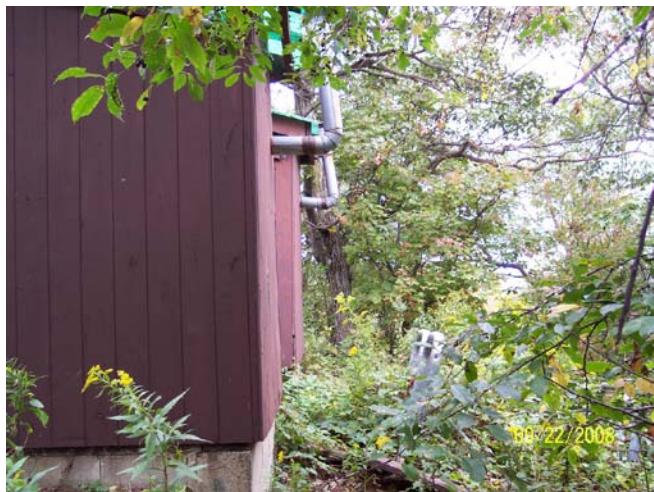
An interview with the manager indicated that she has received some local support with lumber contributions for the tables. The toll booth is the only unit at the base and has a small storage box tacked on for equipment and hand tools. This booth needs to be custom built for this location, placed on a concrete base, and replace the existing unit. A garage at the base appears to be leased for snowmobile activity associated with maintaining the cell towers.

The ADA toilet at the base and the primitive pit toilets at the summit are rough. NHDES has set up air pollution equipment in the CCC building at the summit and somehow contaminated the drinking water being supplied to hikers. There is disinfection equipment combating the e coli but the system is presently shut down just prior to the autumn onslaught. The ugly conduit and water pipe run to the left of the toll road on the surface and could be disguised.

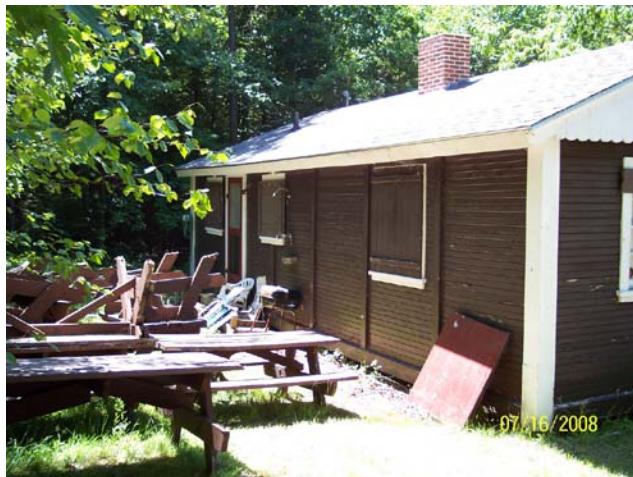
Cottage: Unused cottage by the toll booth gives unfavorable impression to anyone looking closely. The cottage and its shed collect broken tables, etc. and the area about the structures needs a cleanup.

Toilet Building. Good condition. The front half of the structure provides the toilet facility; the rear portion is an open pavilion-style where lumber was being stained.

Garage: The garage area was not neat, tables in front of the overhead door. A broken panel in the overhead door needs attention. A natural drainage is impeded by the driveway to the garage, and perhaps a culvert could be installed to pass runoff.

ADA Pit Toilet. Just off the paved parking lot, but the walk to the door is not paved to threshold which would allow better wheelchair access.

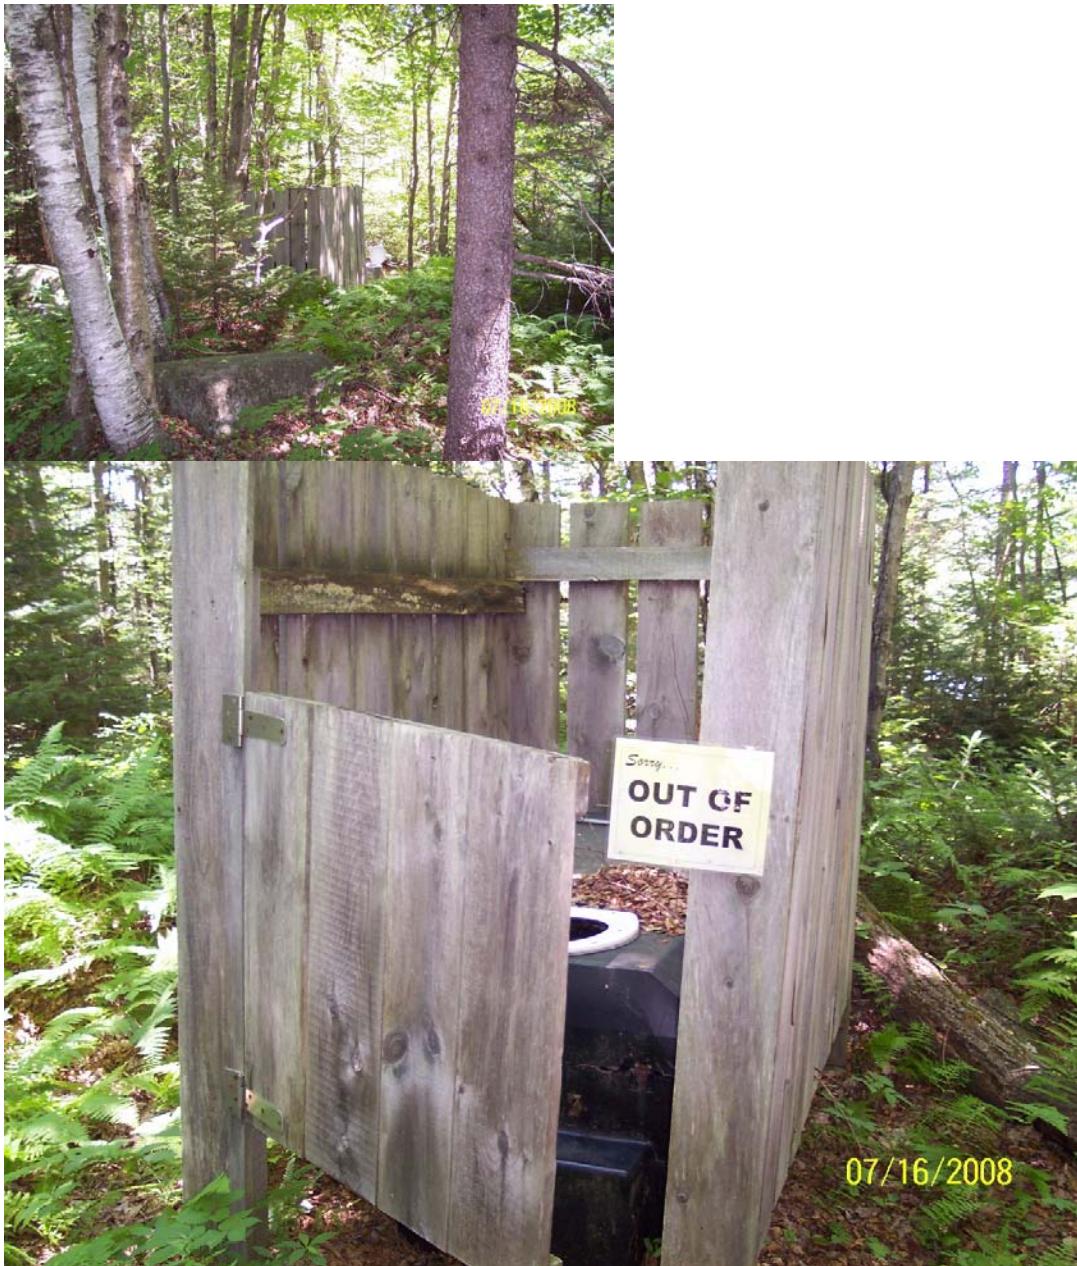
Nice sites, although many crowded unnecessarily, as there is plenty of area. I did walk in to a platform by a pond which unfortunately did not have a proper toilet facility, see below:

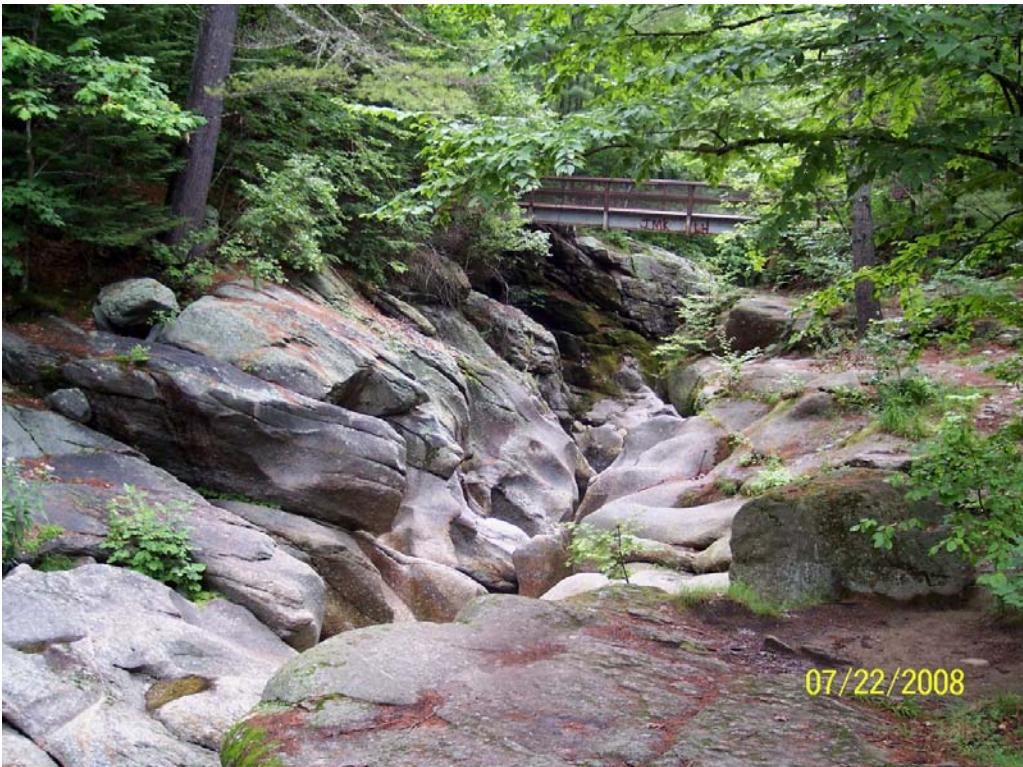
This site is not much more than a wayside, with a parking lot on one side of the road and a brook running through some ledge on the other. It is probably more of a geologic site than a place to go swimming. It would be dangerous for young children to be in this area by the crevasse in the rocks, and there is a substantial steel and timber deck bridge traversing the brook quite high over the rocks.

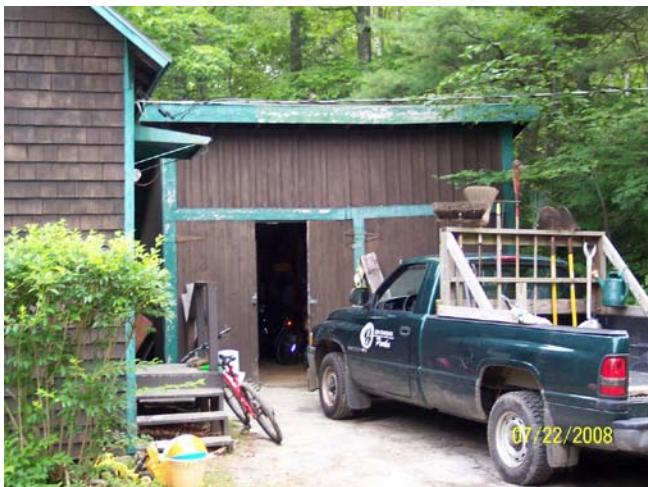
Manager's residence. The FARMS July 2006 survey includes most of the repair items necessary in what they call "moderate to extensive repairs". The heating oil tank recommended to be drained and removed in Ed Mussey's 2006 assessment is still present to the exterior rear of the building. I included in Ed Mussey's 2006

Tool Room/Workshop. This building affected by high water and lack of foundation was recommended for replacement in 2006.

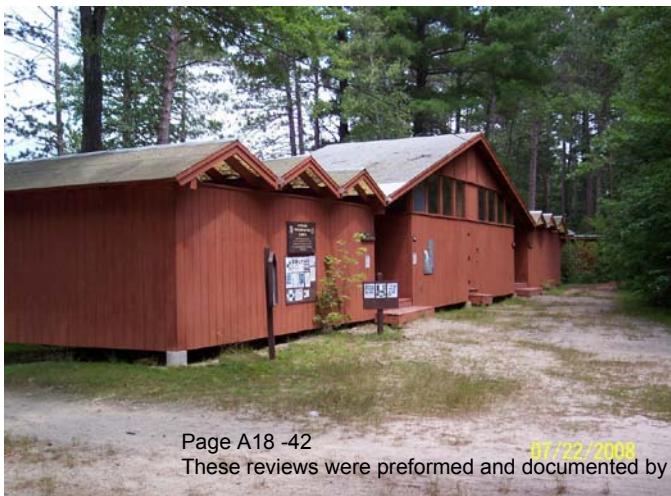
Bathhouse. By observation roofing and rafters have not changed since 2006 when it was recommended that deferred replacement and other maintenance be accomplished.

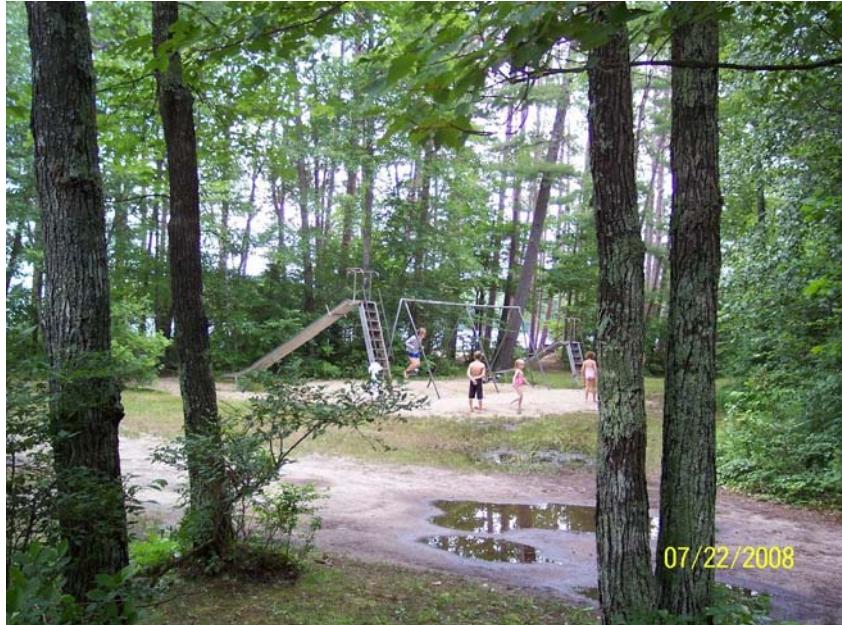
Playgrounds. There are two playgrounds situated on the higher ground surrounded by wetlands. While I don't believe these areas classify as wetlands, it would be beneficial to fill areas by the horseshoe pits and other low elevations affected by the water table in the lake.

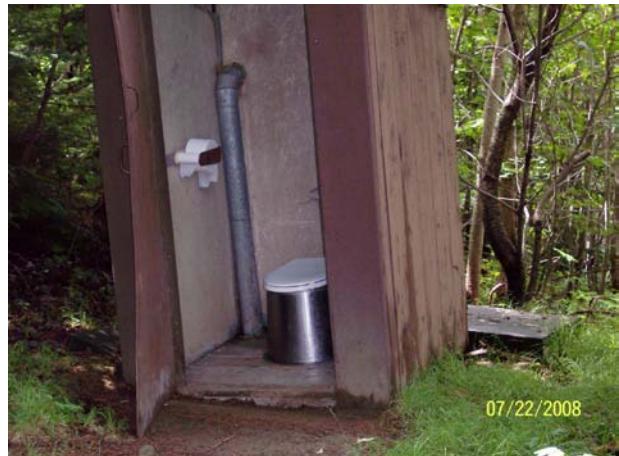
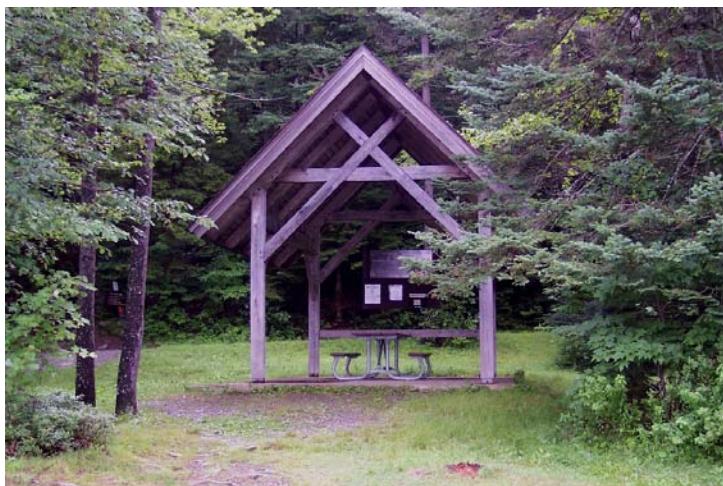
Pit Toilets. The area is serviced by pit toilets. The newer grey building by the parking lot is not ADA accessible. This building appeared to be in good condition. There were also two old-style pit toilets at the other end of the parking lot that were in disrepair and should be removed.

Pavilion. Although built and dedicated in 1990 structure appeared to be in good shape. Here again, it was a structure reaching its twenty year life on the roofing shingles. The trail and the facility appeared to be maintained by volunteers known as the Cardigan Highlanders.
