# BEAR BROOK BEAR HILL

C. SOUTHERN PARKS

NEW HAMPSHIRE STATE PARKS CAMPGROUND EXPANSION FEASIBILITY STUDY

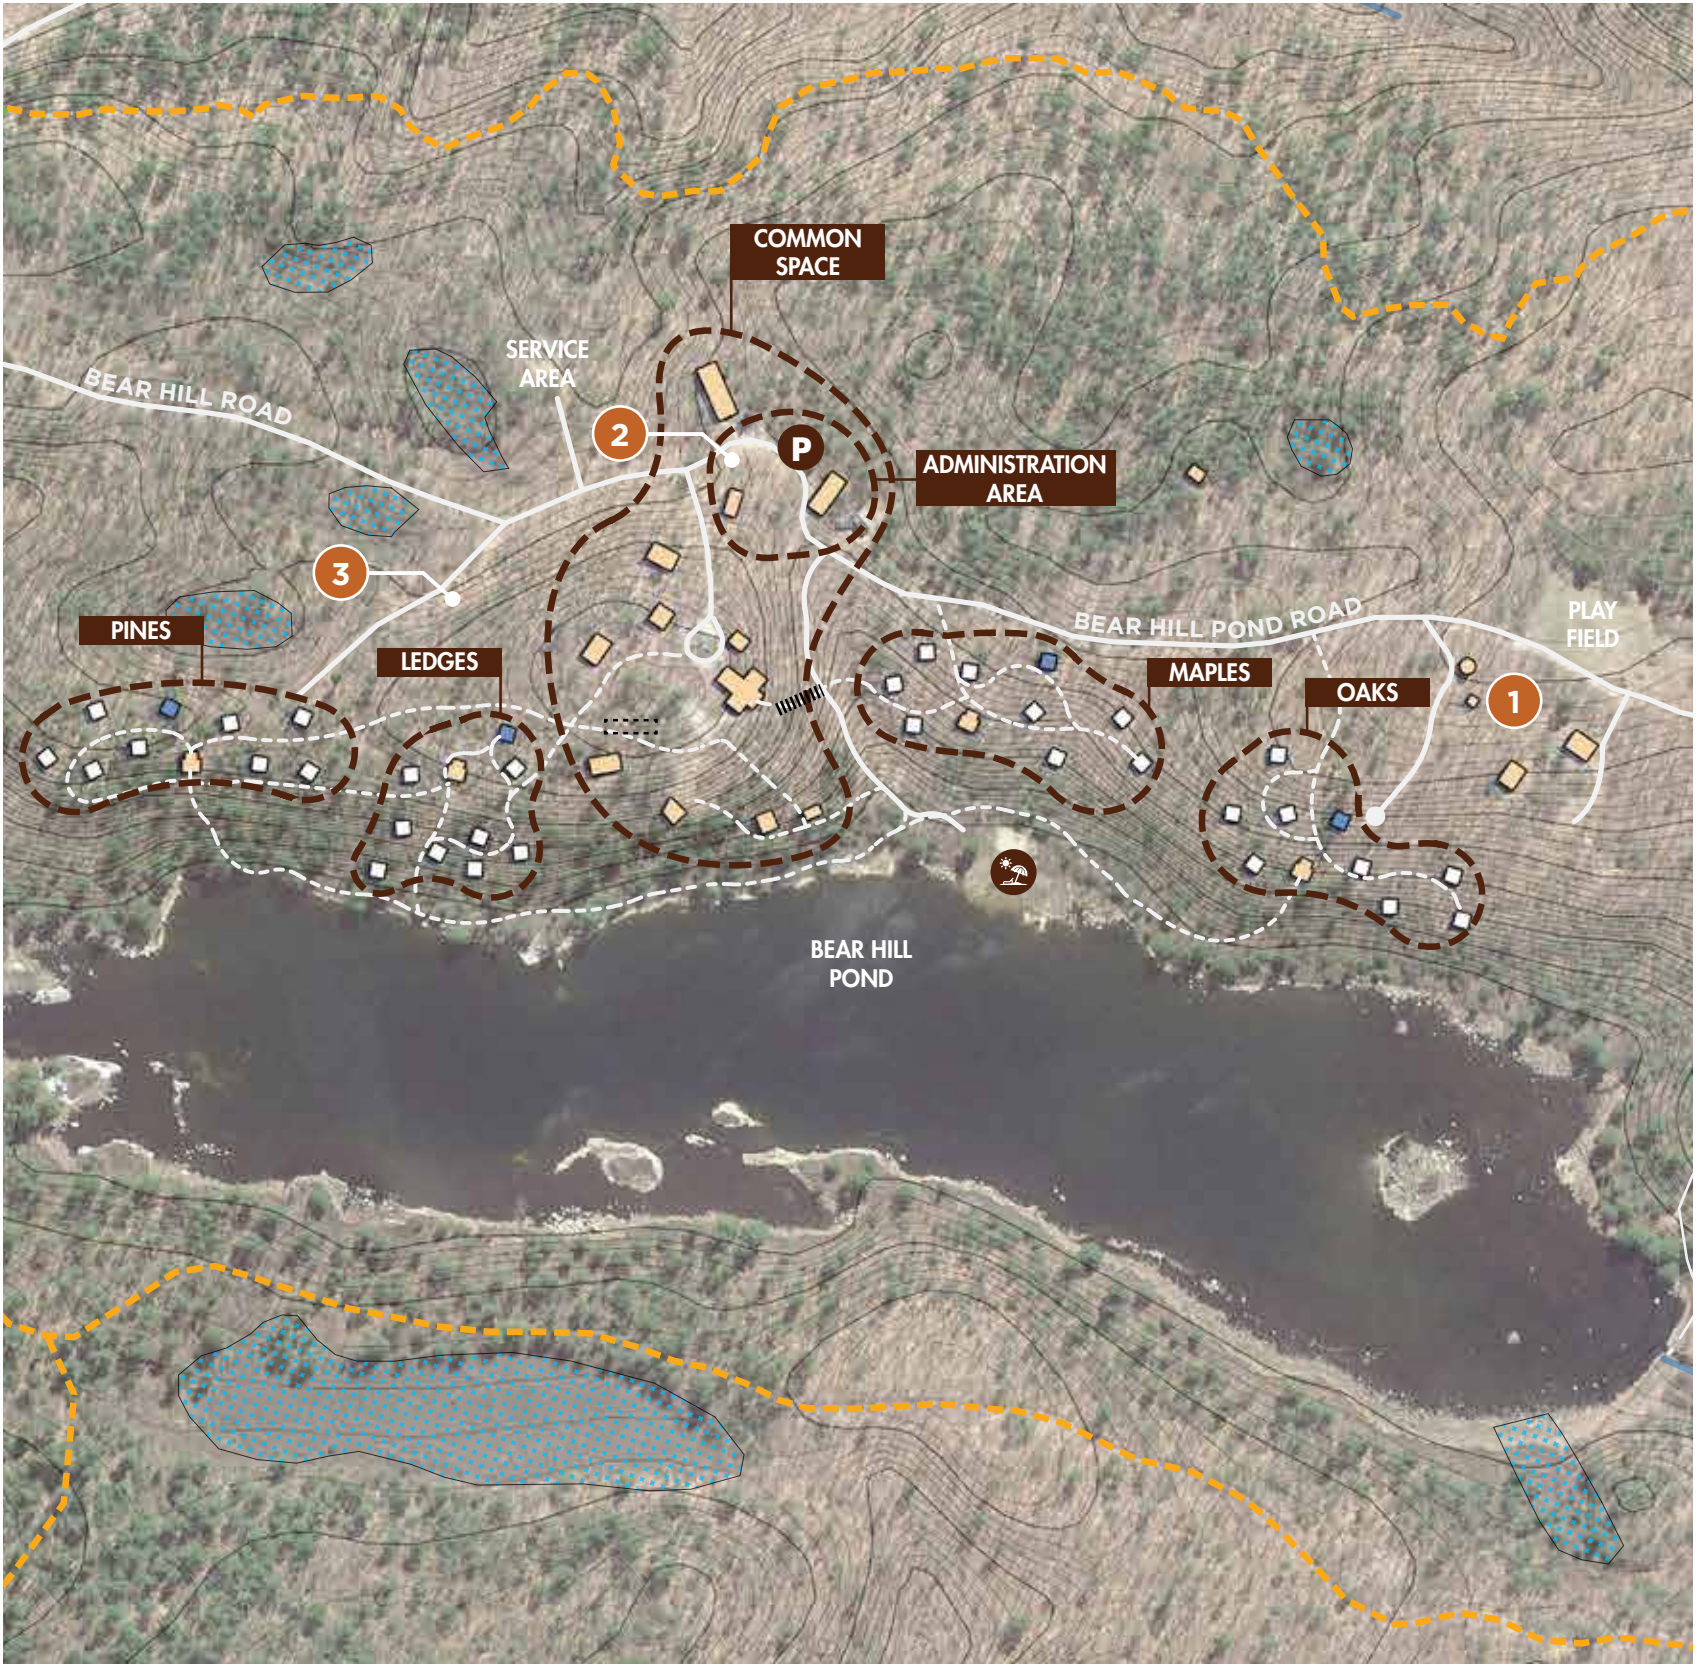
INFRASTRUCTURE

WATER SUPPLY

Water supply is provided by a drilled well that feeds a pump house (1) with a Well-X-Trol WX-250 hydropneumatic pressure tank.

Water is distributed in HDPE piping laid on the ground to the bathroom buildings and various common building with water services. These buildings include bathroom buildings for the Central, Oaks, Maples, Ledges, and Pines, dining hall, infirmary, staff quarters, art studio, and Scannel Hall.

POWER

Power is primarily supplied by overhead distribution (2).

WASTEWATER

Central Leach Field: The buildings served by the central leach field (3) were not definitively identified. It appears that the Pines and Ledges washhouses both have wastewater tanks with a pump system that most likely sends wastewater to the central leach field. The condition and functionality of the pump systems is unknown. We assume the infirmary and the dining hall are served by tanks that gravity flow to the leach field.

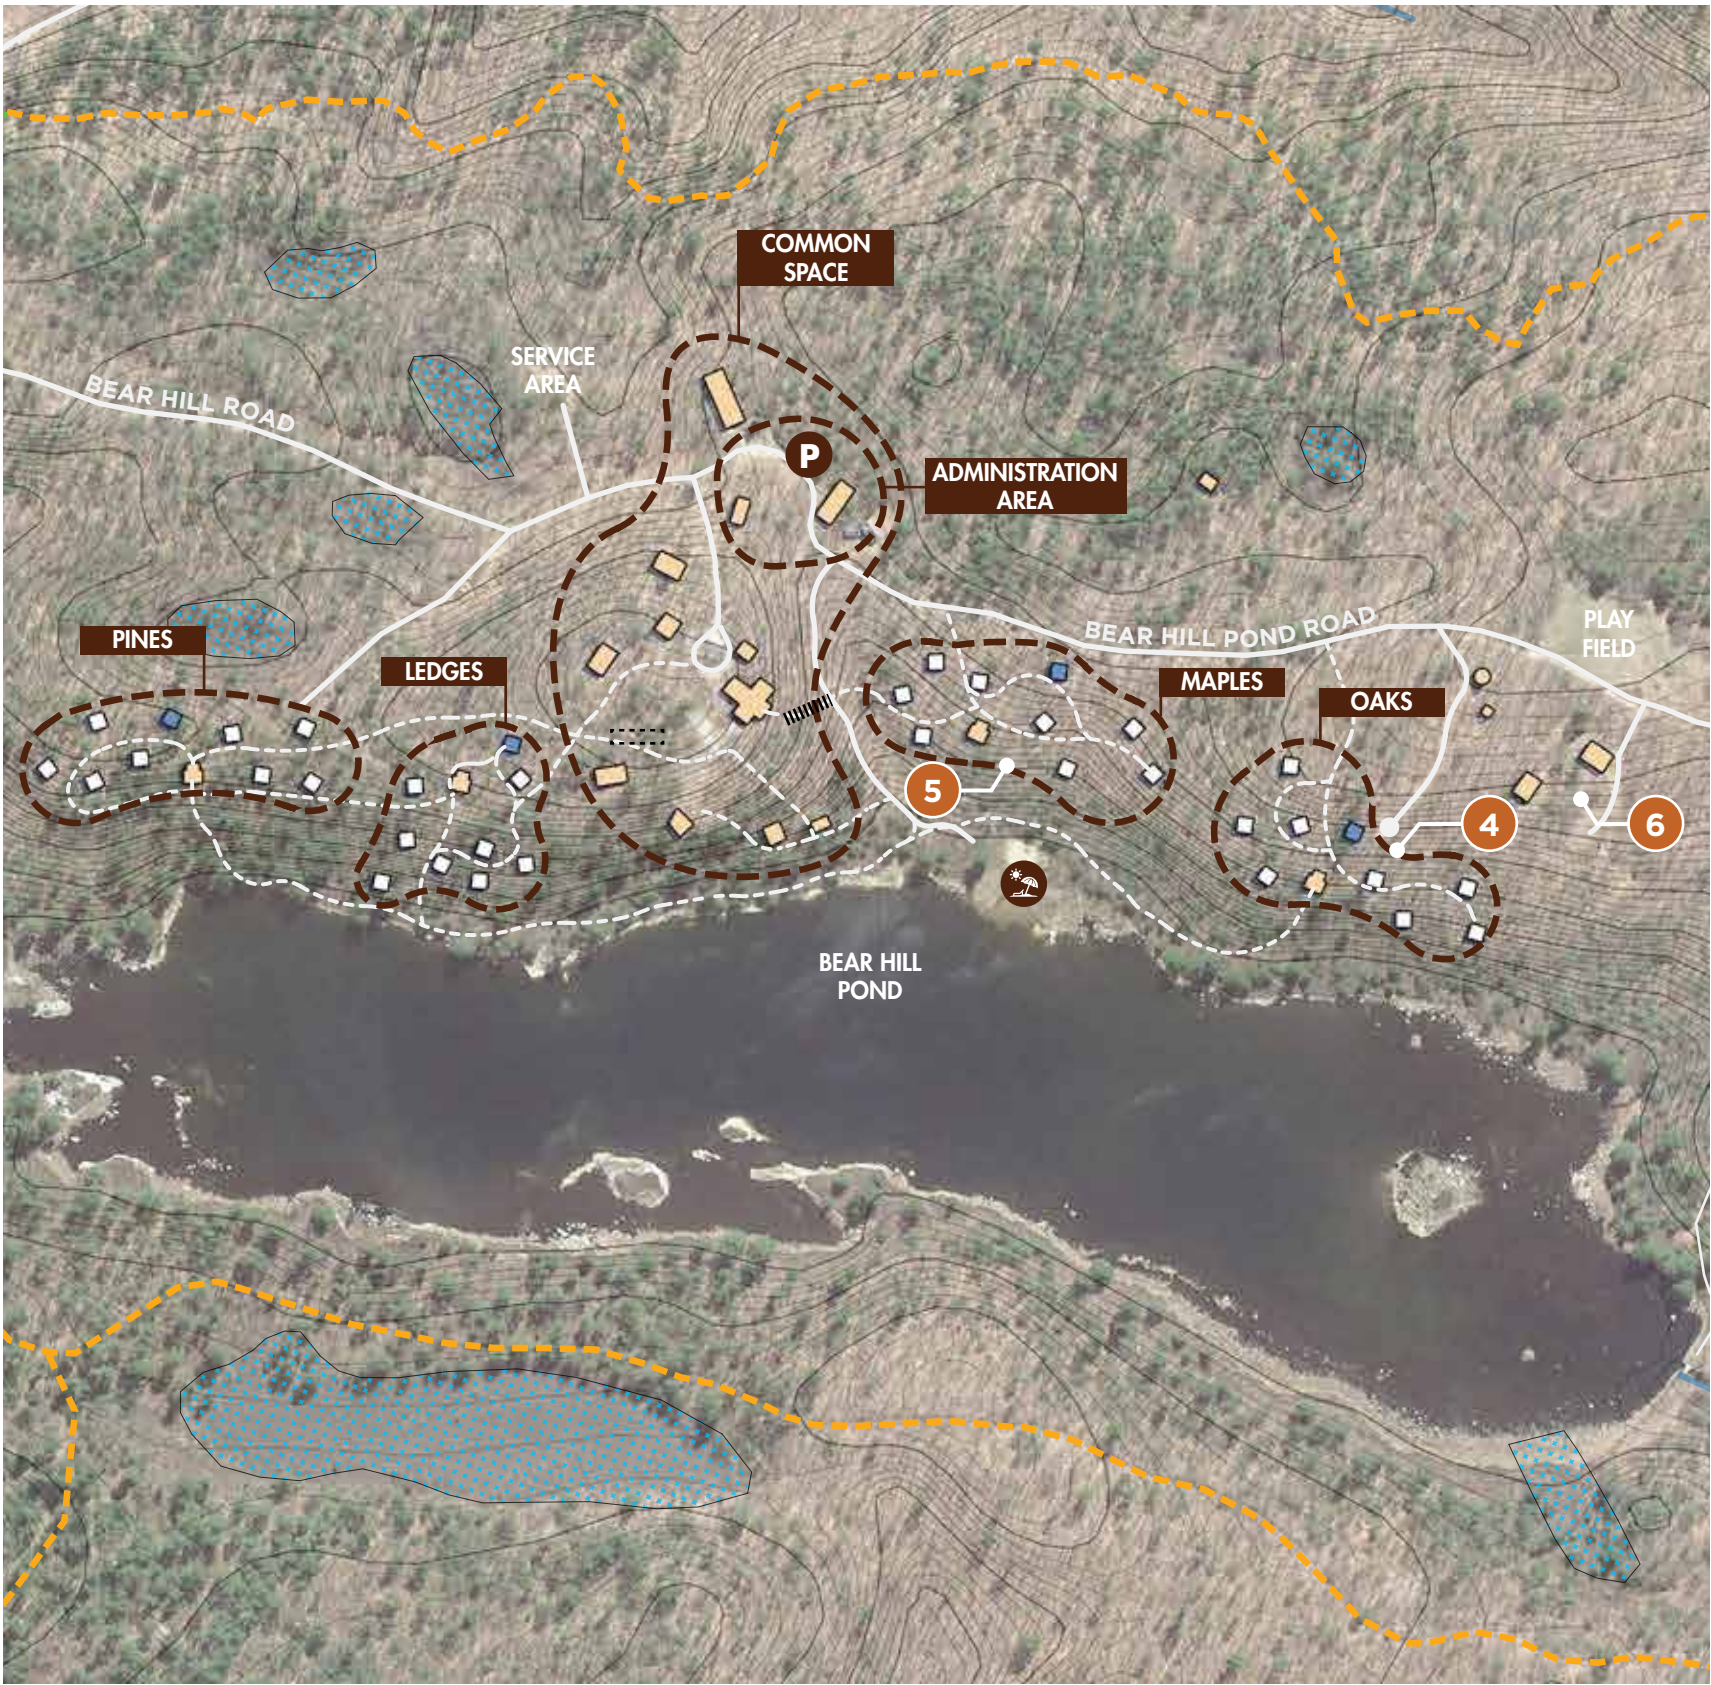
INFRASTRUCTURE

WASTEWATER CONTINUED

Art Studio: This building has a wash sink only and no bathrooms or other wastewater use. An apparent old wastewater pipe was observed leaving underneath the building to the north.

Oaks Washhouse: A tank gravity feeds to a distribution box and leach field **(4)**. The system appears to be in good working condition.

The Maples Washhouse: A tank gravity feeds to a distribution box and leach field. The tank and distribution box are a bit more removed from the immediate building area, and the leach field **(5)** is down the trail in a clearing west of the cabin cluster.

Shower Building: There is reportedly a tank with a leach field **(6)**.

Pit Toilet (BBR100): There is an old hot water tank that is not in use, possibly used for handwashing, but no water supply or wastewater system were observed.

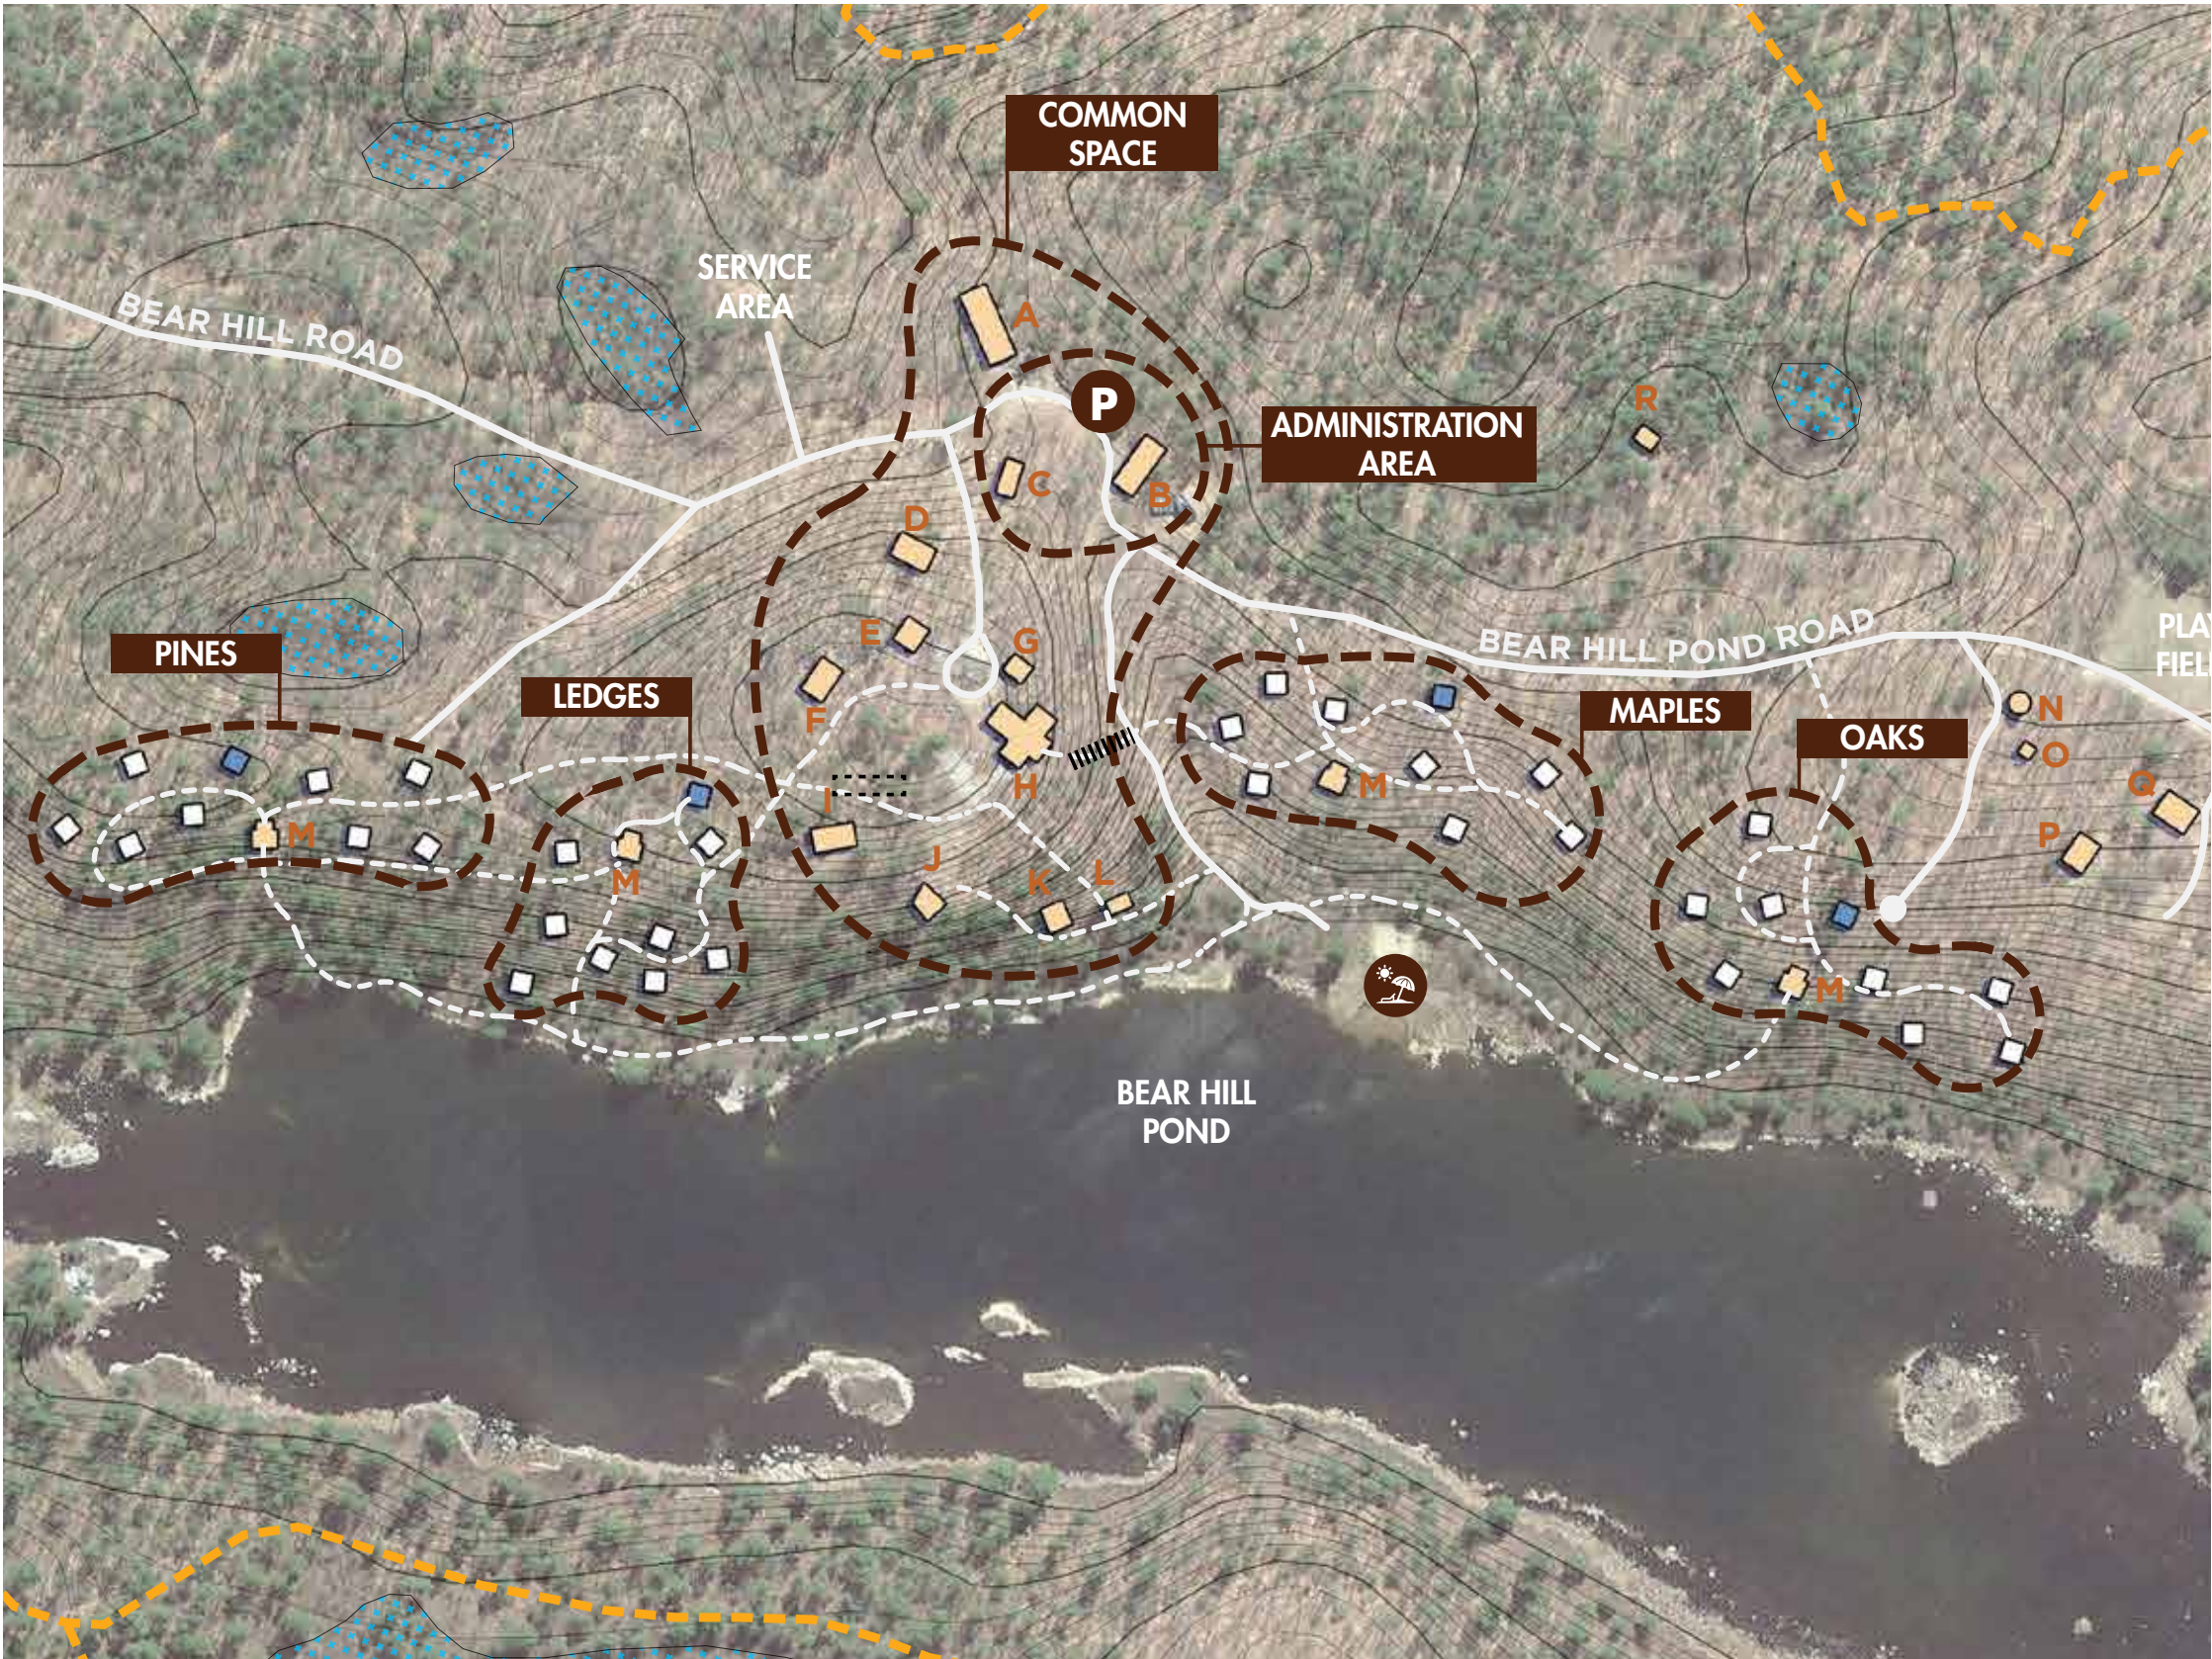
- 32 CABINS\*
- 4 WASHHOUSES\*
- 18 SHARED STRUCTURES

\* Structures with Historic Significance

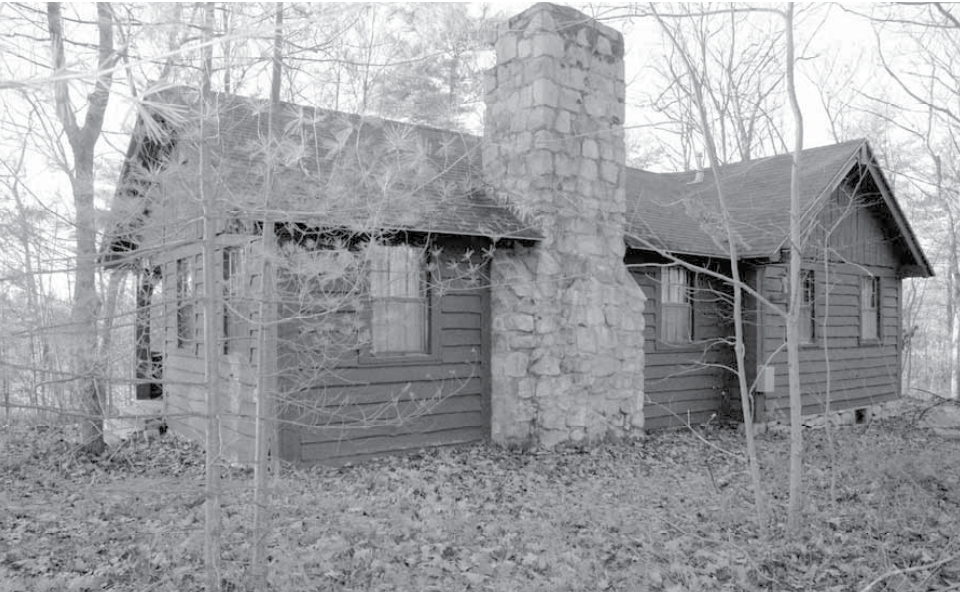
STAFF QUARTERS

Built	1936
Size	41'-3"x17'-9"
Construction Type	Stone foundation, stone fireplace, stick framing, double hung windows, waney board siding, recent metal roofing. gable roofing porch, heavy timber construction. Electric and plumbing utilities.
General Condition	Overall the structure is in good condition. Typical repair of stone foundation, windows repaired or replaced, general clean up & carpentry. Stone fireplace that needs inspection.
History	Staff housing four bedrooms, main living room and large porch. Did not have bathroom and kitchen.
Potential Re-Use	Future camp operation could redesign interior for staff housing or group rental. Possible addition of bathrooms with septic connection
Accessible	Doesn't meet current ADA standards, but could be provided.
Historically Significant	Yes

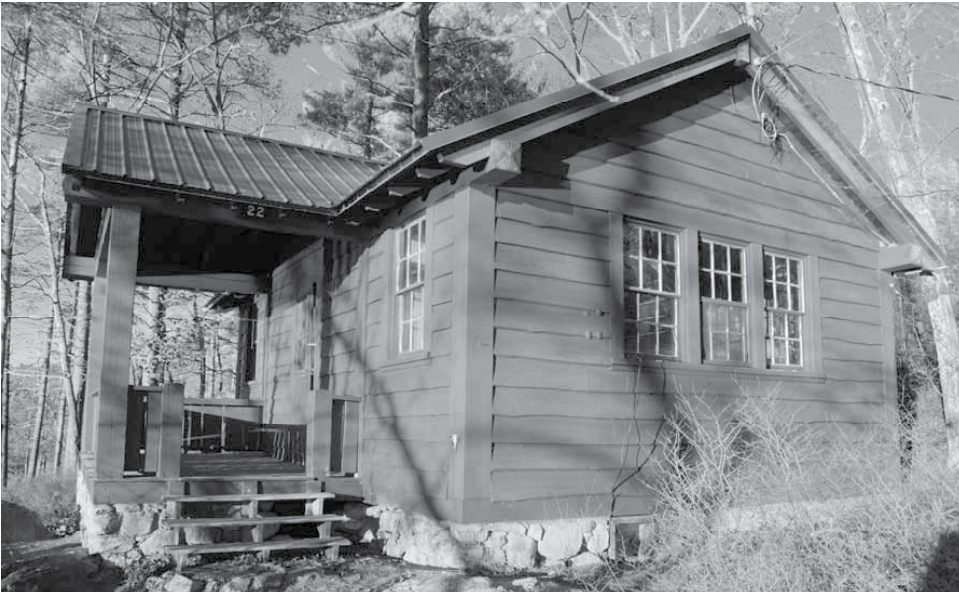
CRAFT CABIN

Built	1937
Size	27 1/2' X 19'-0"
Construction Type	Stone foundation, stick framing, double hung windows, waney board siding, porch, electric and plumbing utilities.
General Condition	General condition is good needing typical repair of stone foundation, general carpentry windows repaired or replaced, interior demo of more recent additions to the interior..
History	Used by camp organizations for craft and other workshop activities.
Potential Re-Use	Could be reconfigured to be large group family rental cabin. Excellent location with view of pond. Possible addition of bathrooms with septic connection (pump station needed).
Accessible	Doesn't meet current ADA standards, but could be provided.
Historically Significant	Yes

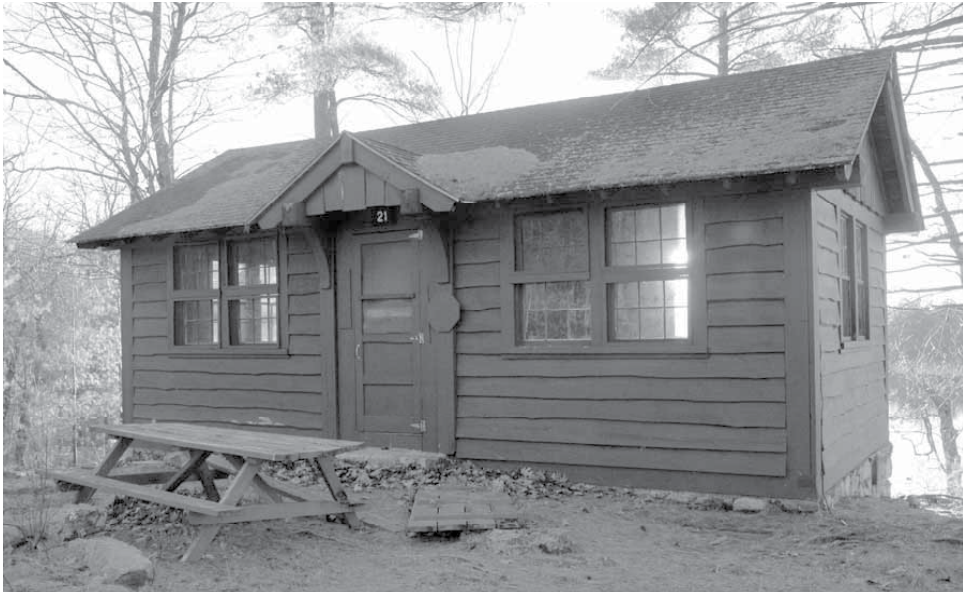
NATURE LODGE

Built	1936
Size	27'-6"x14'-6"
Construction Type	Stone foundation, stick framing, double hung windows, waney board siding, recent metal roofing. gable roofing porch heavy timber construction. Electric and plumbing utilities.
General Condition	Overall the structure is in good condition. Typical repair of stone foundation, windows repaired or replaced,
History	Nature museum and nature "base" exhibits with displays and cabinets for programs for campers
Potential Re-Use	Good location overlooking pond. Good rental cabin for larger groups and families. Possible addition of bathrooms with septic connection (pump station needed).
Accessible	Doesn't meet current ADA standards, but could be provided.
Historically Significant	Yes

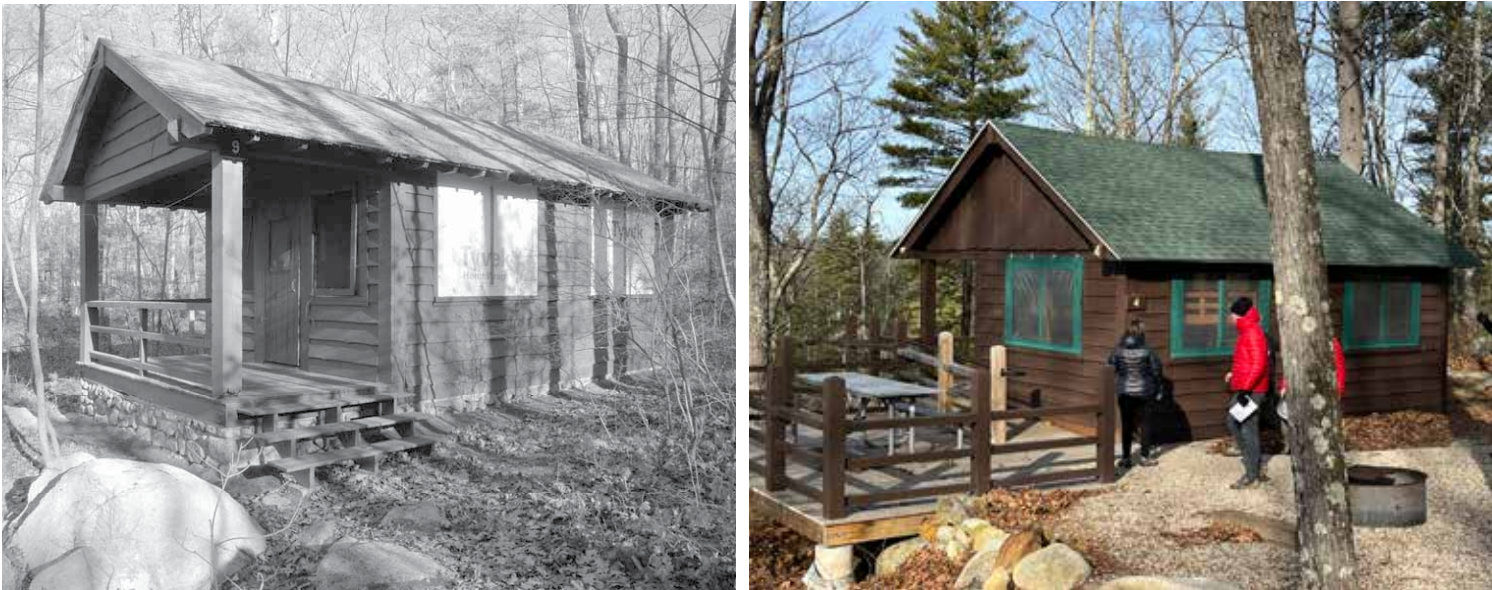
CABINS

Built	1936
Number of Buildings	24
Size	12'-6"x20'x6" 13'x19'-4
Construction Type	Stone foundation, stick framing, double hung windows, waney board siding, recent metal roofing. gable roofing porch heavy timber construction.
General Condition	The condition of the remaining cabins varies quite a bit, but in general all need some stone foundation repair, replacement of some wood foundation sills, waney board replacement, re-roofing, interior clean up and general carpentry.
History	Sleeping cabin for 4 campers,
Potential Re-Use	Continue with original use with some upgrades by adding more ADA accessible cabins, window. Could sleep 6 guests.
Accessible	Some cabins can be made ADA accessible.
Historically Significant	Yes
Summary of Renovations for the Oaks Unit	Historical character has been maintained with only minimal modifications, i.e. window storm shades, ADA accessibility, modified porch railing.

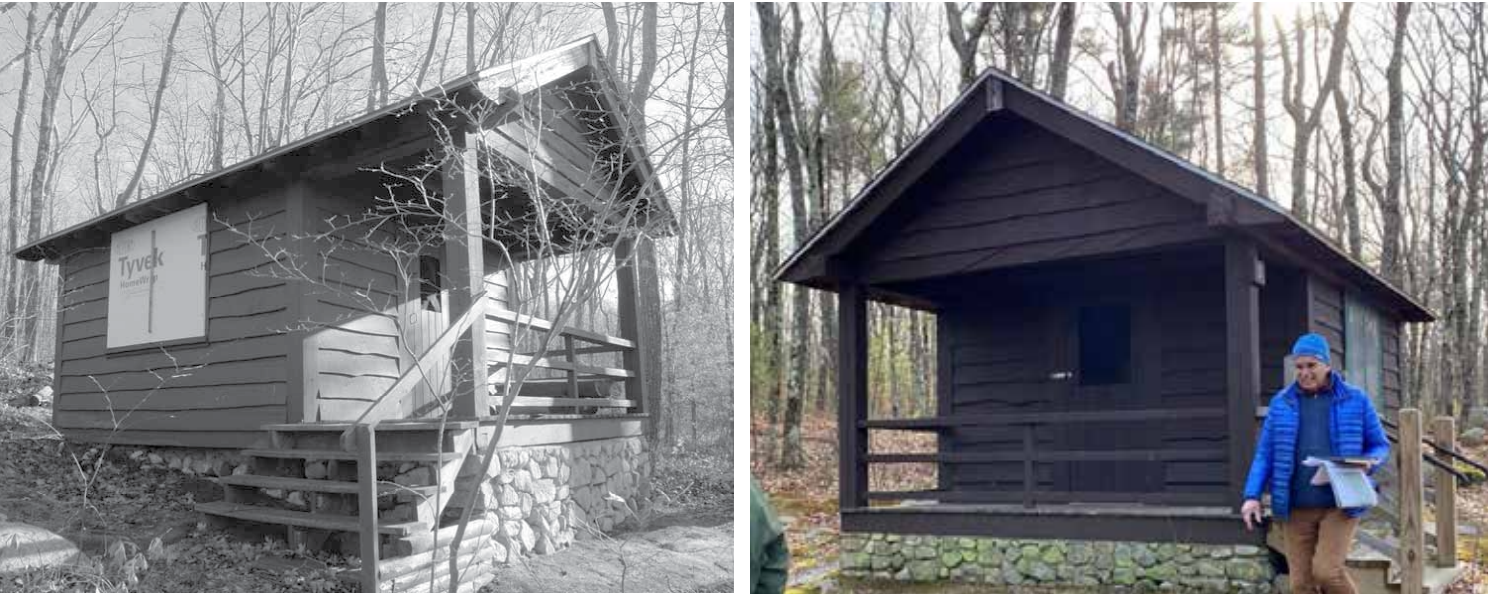
COUNSELOR CABIN

Built	1936
Number of Buildings	6
Size	14'x12'
Construction Type	Stone foundation, stick framing, double hung windows, waney board siding, recent metal roofing. gable roofing porch heavy timber construction.
General Condition	Cabin conditions vary; problems with foundation, siding framing, windows are consistent with all cabins, but some are worse than others.
History	Sleeping cabin for two counselors.
Potential Re-Use	Camper cabin for four.
Accessible	Doesn't meet ADA Accessibility, but could be provided.
Historically Significant	Yes
Summary of Renovations for the Oaks Unit	Historical character has been maintained with only minimal modifications, i.e. window storm shades, improved accessibility, modified porch railing.

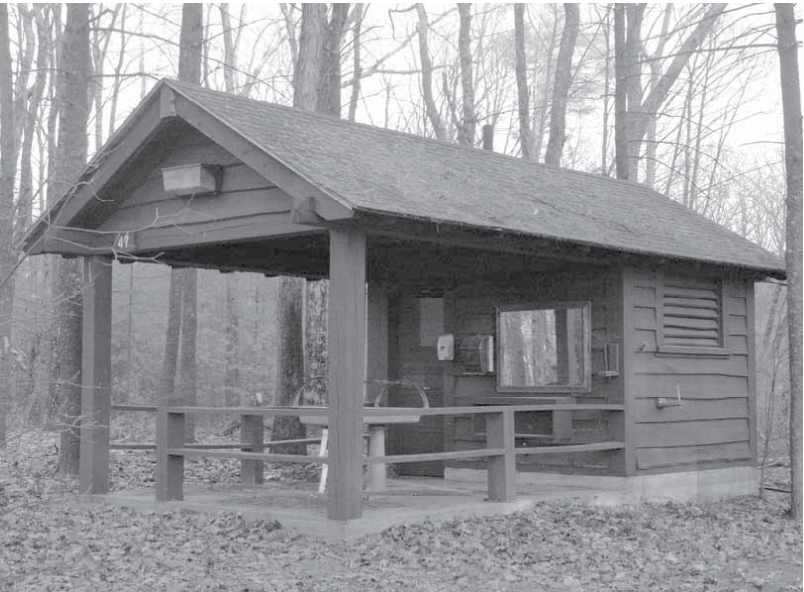
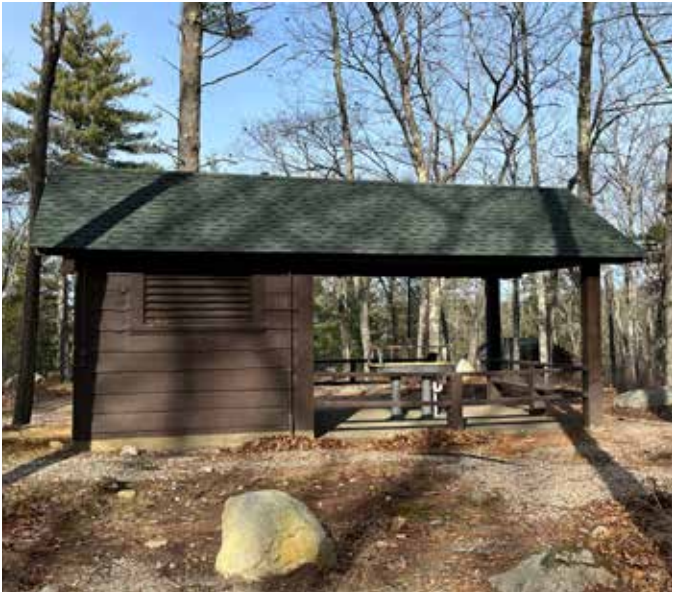
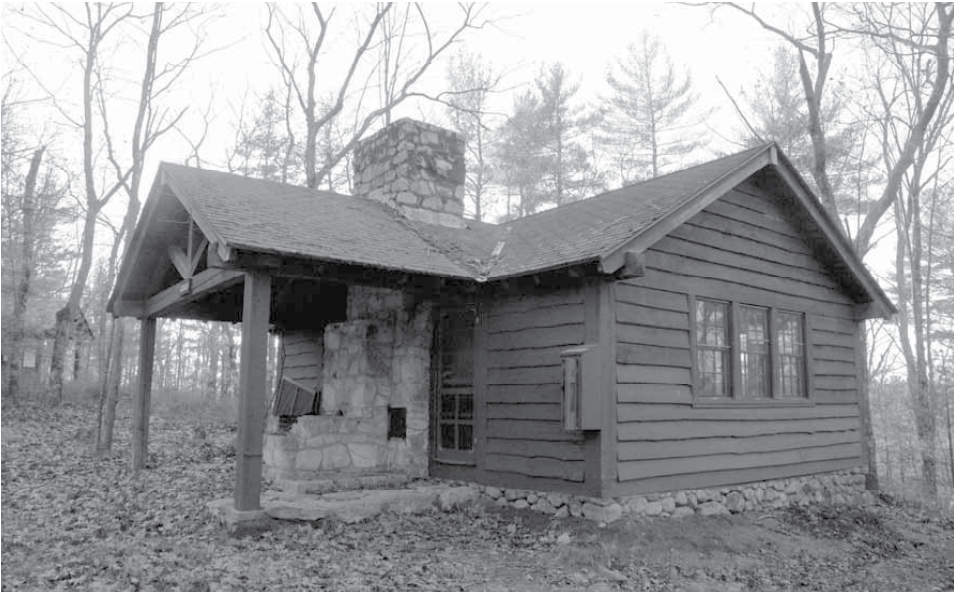
WASH HOUSE

Built	1936
Number of Buildings	4
Size	21'-3"x10'-6"
Construction Type	Slab on grade, stick framing, double hung windows, waney board siding, shingle roofing, porch with heavy timber construction. Electric and plumbing utilities. Slab on grade.
General Condition	Unrenovated building shells are generally in same condition as other buildings. Interior will need new toilet and wash facilities and interior finishes that are hygienically appropriate.
History	Latrine and wash house had three stalls inside.
Potential Re-Use	Renovate to accessible restroom standards.
Accessible	Doesn't meet ADA Accessibility, but could be provided.
Historically Significant	Yes
Summary of Renovations for the Oaks Unit	Renovated several years ago with a toilet and sink and interior paneling.

Built	1936
Number of Buildings	4
Size	728 square feet
Construction Type	Stone foundation, stick framing, double hung windows, waney board siding, recent metal roofing. gable roofing porch heavy timber construction.
General Condition	The condition varies quite a bit, but in general all need some stone foundation repair, replacement of some wood foundation sills, waney board replacement, re-roofing, interior clean up and general carpentry, and window repair or replacement.
History	Meeting place for unit campers to get together for activities.
Potential Re-Use	Would make a good group and family cabin rental or continue original use as a meeting place for campers.
Accessible	Doesn't meet ADA accessible, but could be provided.
Historically Significant	Yes
Summary of Renovations for the Oaks Unit	Historical character has been maintained with only minimal modifications, i.e. window storm shades, improved accessibility, modified porch railing.

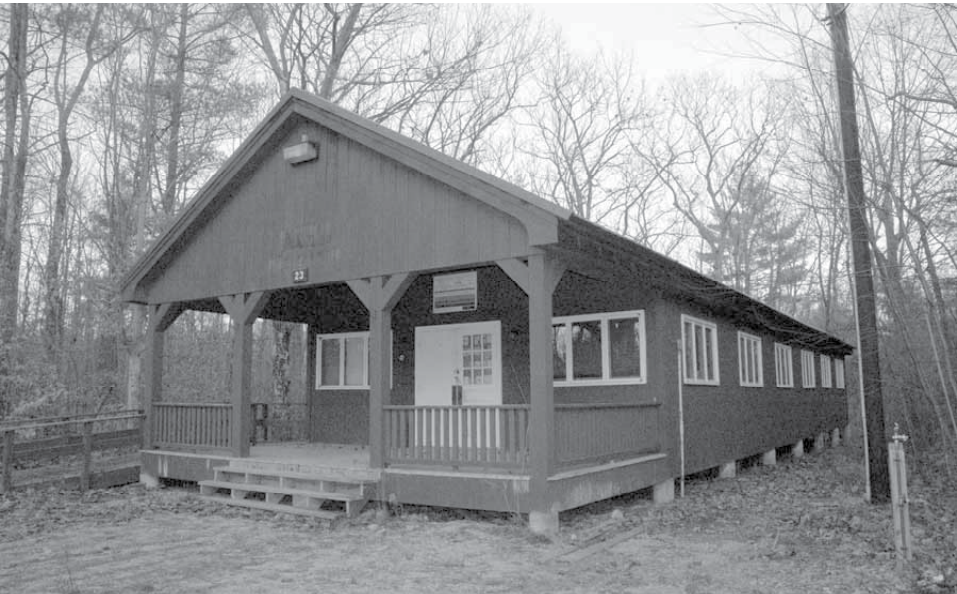
SCANNEL HALL

Built	1972
Size	2002 square feet
Construction Type	Standard stick construction with wood truss roof framing, concrete slab, pier foundation, TS-11 siding casement windows. Electric service provided.
General Condition	Good condition, solid construction, not part of original camp.
History	Replaced burned down original recreation building, and was used as recreation building ad general assembly.
Potential Re-Use	Building is a large hall and probably would continue to serve that purpose or office/ store.
Accessible	Yes
Historically Significant	No

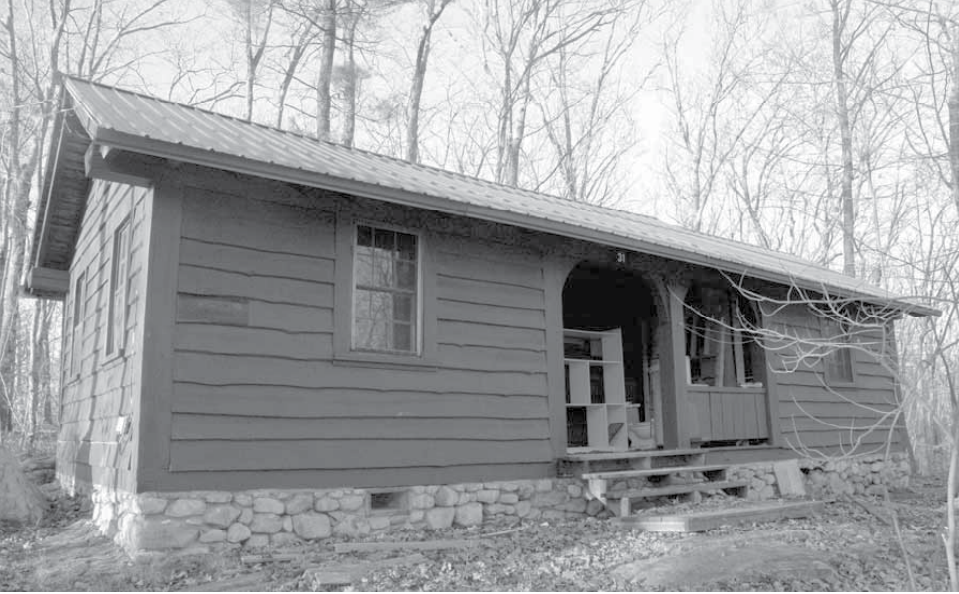
HELPS QUARTER'S

Built	1936
Size	660 square feet; 36"x17"
Construction Type	Slab on grade, stick framing, double hung windows, waney board siding, recent metal roofing, heavy timber construction.
General Condition	Overall good condition needing typical repair of stone foundation, windows repair or replace, interior clean up clean up and general carpentry.
History	Camp service employees housing.
Potential Re-Use	Could be converted into larger rental cabin for groups and families, or camp staff housing.
Accessible	Doesn't meet current ADA standards, but could be provided.
Historically Significant	Yes

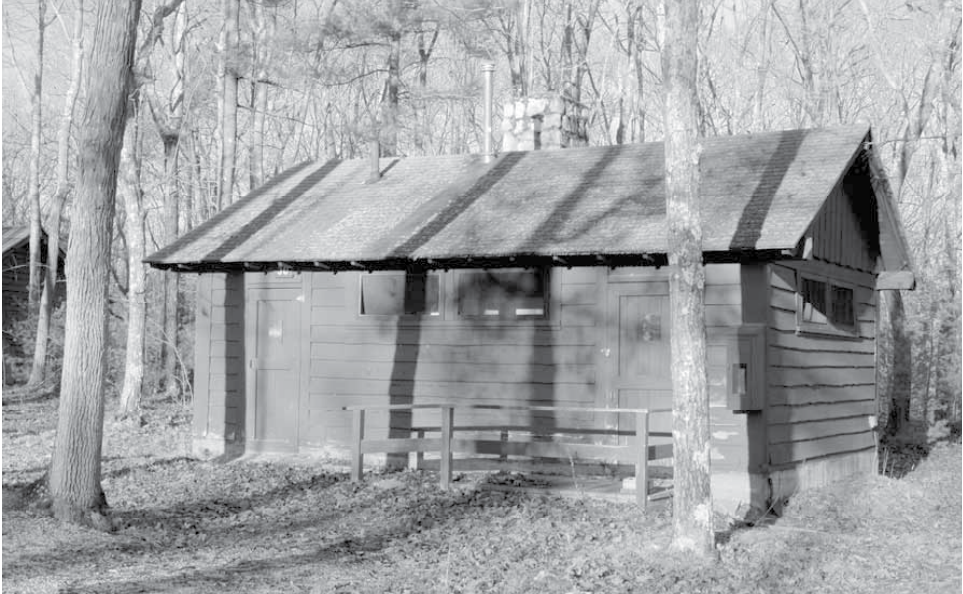
CENTRAL WASH HOUSE

Built	1936
Size	11'0"x21'-3"
Construction Type	Stone foundation, concrete foundation, stick framing, double hung windows, waney board siding, recent metal roofing. gable roofing porch heavy timber construction. Electric and plumbing utilities.
General Condition	Overall the structure is in good condition. Typical repair of stone foundation, windows replace or repair), general clean up & carpentry, interior is tongue and groove paneling.
History	Original building with shower room, two small bathrooms, dressing area.
Potential Re-Use	Could have modernized interior layout and design and continue to be a wash house. Connected to camp electrical, water and septic system.
Accessible	Doesn't meet current ADA standards, but can be provided.
Historically Significant	Yes

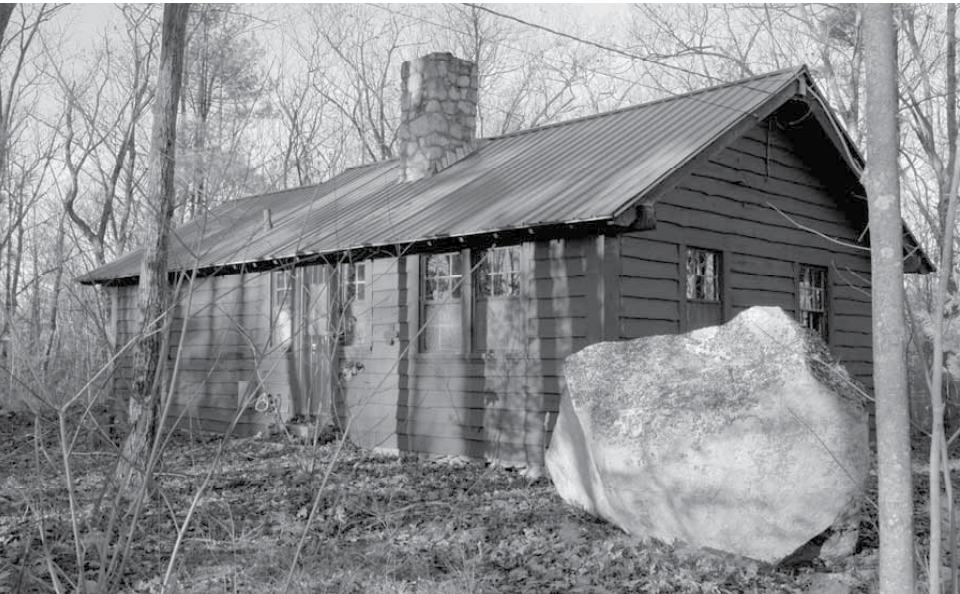
INFIRMARY

Built	1936
Size	812 square feet
Construction Type	Stone foundation, stick framing, double hung windows, waney board siding, recent metal roofing. Electric and plumbing utilities (1990).
General Condition	General condition is good needing typical repair of stone foundation, general carpentry windows repaired or replaced, interior demo of more recent additions to the interior..
History	Infirmary with required spaces, three bedrooms, nurses bedroom, dispensary laundry, and bathroom.
Potential Re-Use	Could be converted into bath house with toilets, shower, and laundry.
Accessible	Doesn't meet current ADA standards, but could be provided.
Historically Significant	Yes

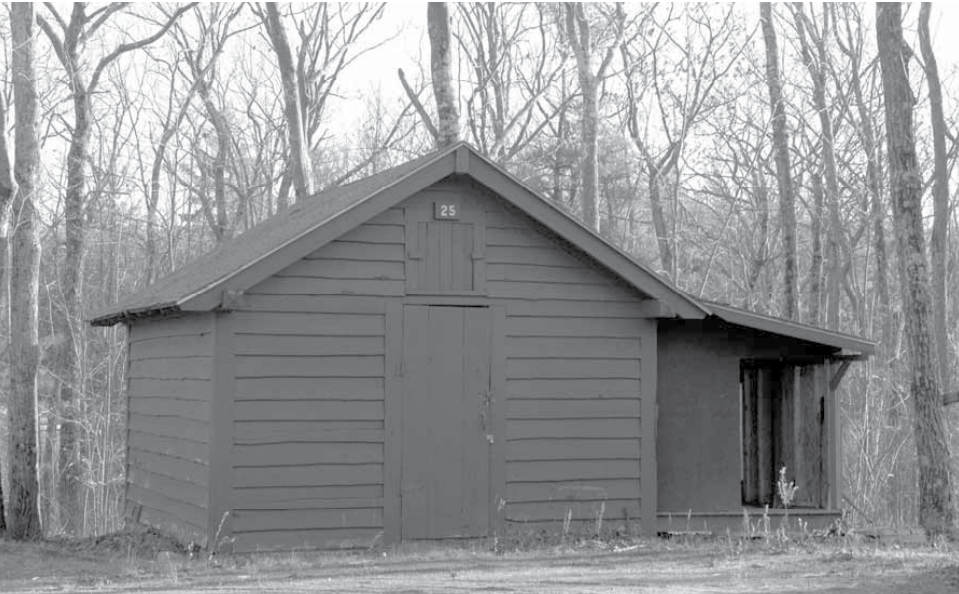
ICE HOUSE/STORAGE

Built	1936
Size	300 square feet
Construction Type	Stone foundation, stick framing, double hung windows, waney board siding, recent metal roofing.
General Condition	Poor
History	Storage of cut ice and kitchen supplies.
Potential Re-Use	Unknown
Accessible	No
Historically Significant	Yes

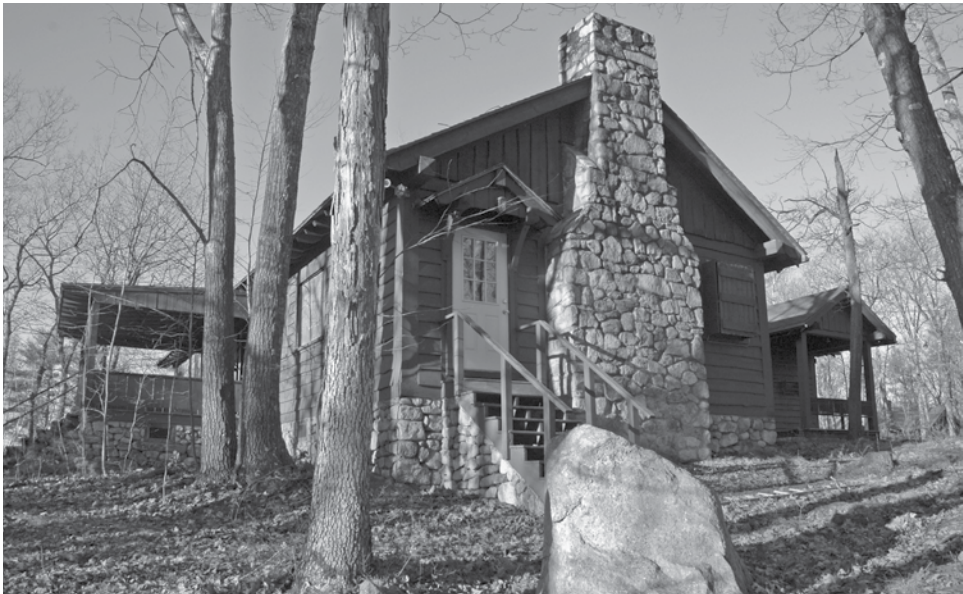
KITCHEN/DINING HALL

Built	1936
Size	2363 square feet with "T" shape plan.
Construction Type	Stick built construction, stone fireplace, waney board siding, exposed rafters, heavy timber framing of porch, large window openings for screens.
General Condition	This building is used as a place of assembly would need complete structural analysis of frame, many modifications and repairs done over the years particularly after 1971 time. Building will need significant repairs and upgrades.
History	Dining, kitchen, assembly, and meetings.
Potential Re-Use	Could be renovated to be a kitchen and dining hall. Good size and location with view of the lake.
Accessible	Doesn't meet current ADA standards, but could be provided.
Historically Significant	Yes

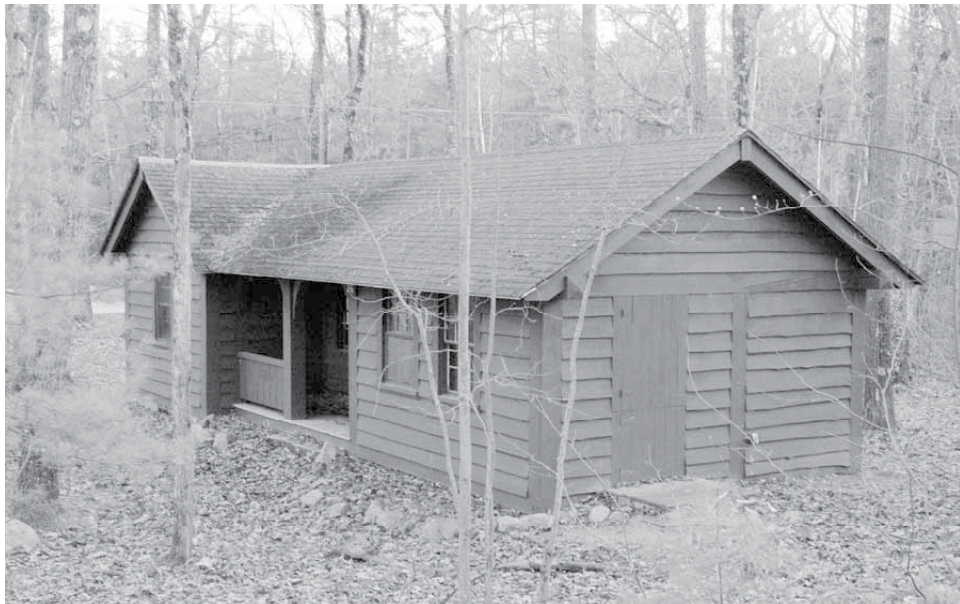
ADMINISTRATION BUILDING

Built	1936
Size	674 square feet
Construction Type	Stone foundation, stick framing, double hung windows, waney board siding, recent metal roofing. Electric service provided.
General Condition	Overall good condition needing typical repair of stone foundation, windows repair or replace, interior clean up and general carpentry.
History	Administrative offices and camp store, “canteen.”
Potential Re-Use	Could continue to be used for administrative services for future camp operations.
Accessible	Doesn’t meet current ADA standards, but could be provided.
Historically Significant	Yes

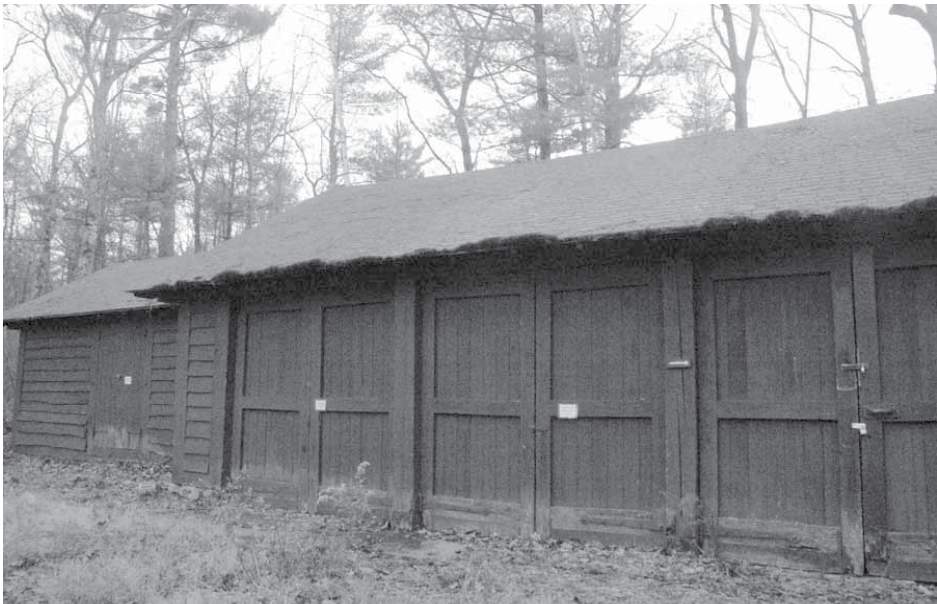
MAINTENANCE GARAGE

Built	1936
Size	3 Bay Garage
Construction Type	Slab on grade, stick framing, double hung windows, waney board siding, recent metal roofing. Electric service provided, and plumbing is unknown.
General Condition	Appears to be in similar condition as other buildings, but needs a more thorough inspection.
History	Vehicle storage and maintenance workshop and storage.
Potential Re-Use	Garage/workshop/firewood storage
Accessible	Possibly
Historically Significant	Yes

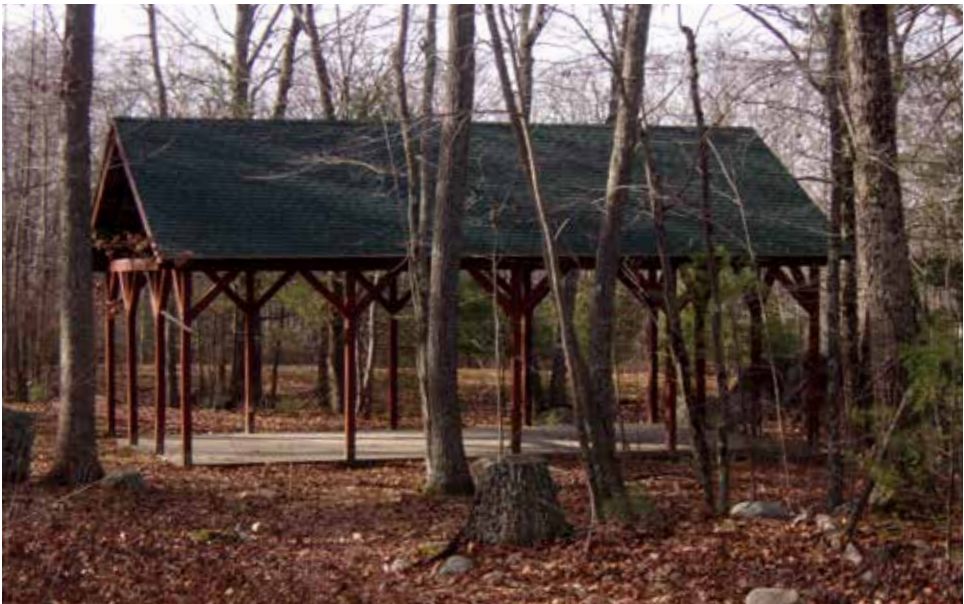
PICNIC SHELTER

Built	1998
Size	864 sf.
Construction Type	Wood Frame/Slab on Grade
General Condition	Decent condition
History	Built by 4H Club
Potential Re-Use	Picnics gathering
Accessible	Yes
Historically Significant	No
