# BEAR BROOK BEAR HILL

C. SOUTHERN PARKS

NEW HAMPSHIRE STATE PARKS CAMPGROUND EXPANSION FEASIBILITY STUDY

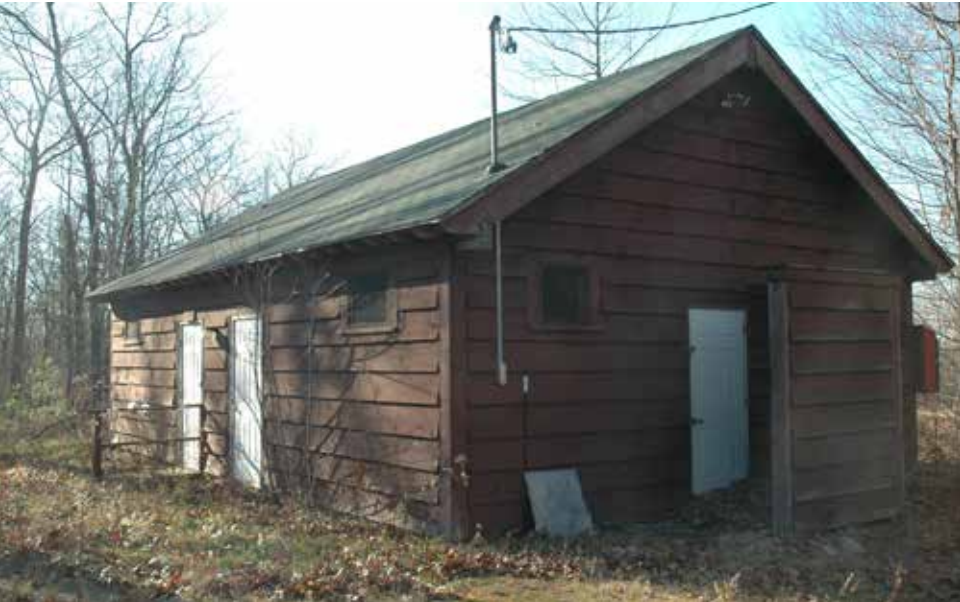
SHOWER BUILDING

Built	2000
Size	864 sf.
Construction Type	Wood Frame
General Condition	Poor
History	Built by 4H Club
Potential Re-Use	Duplex Staff Housing
Accessible	Yes
Historically Significant	No

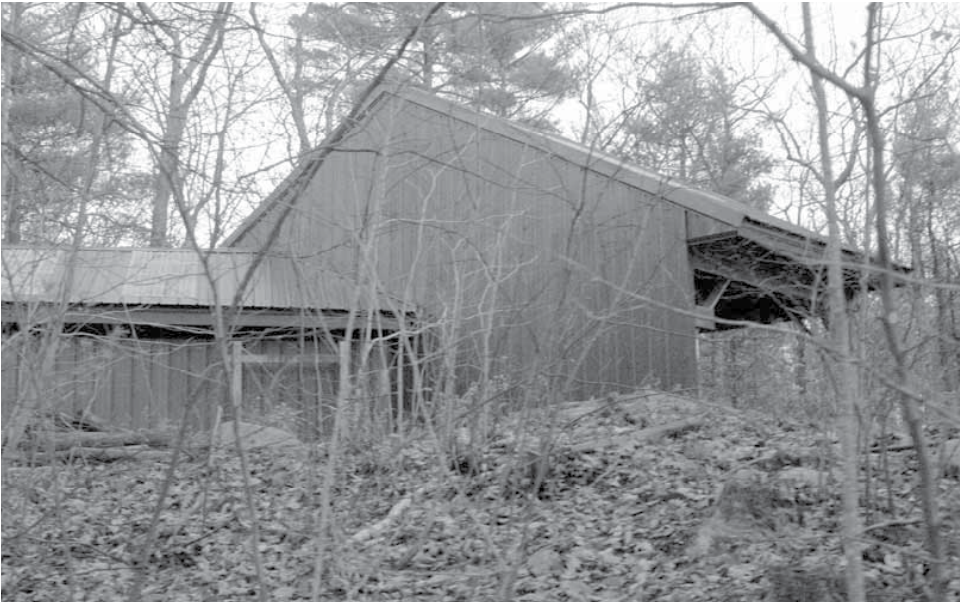
ARCHERY SHED

Built	Not Available
Size	+/- 1000 sf.
Construction Type	Wood and Metal Roofing
General Condition	Appears to be in descent condition
History	Built by 4H Club
Potential Re-Use	No
Accessible	No
Historically Significant	No

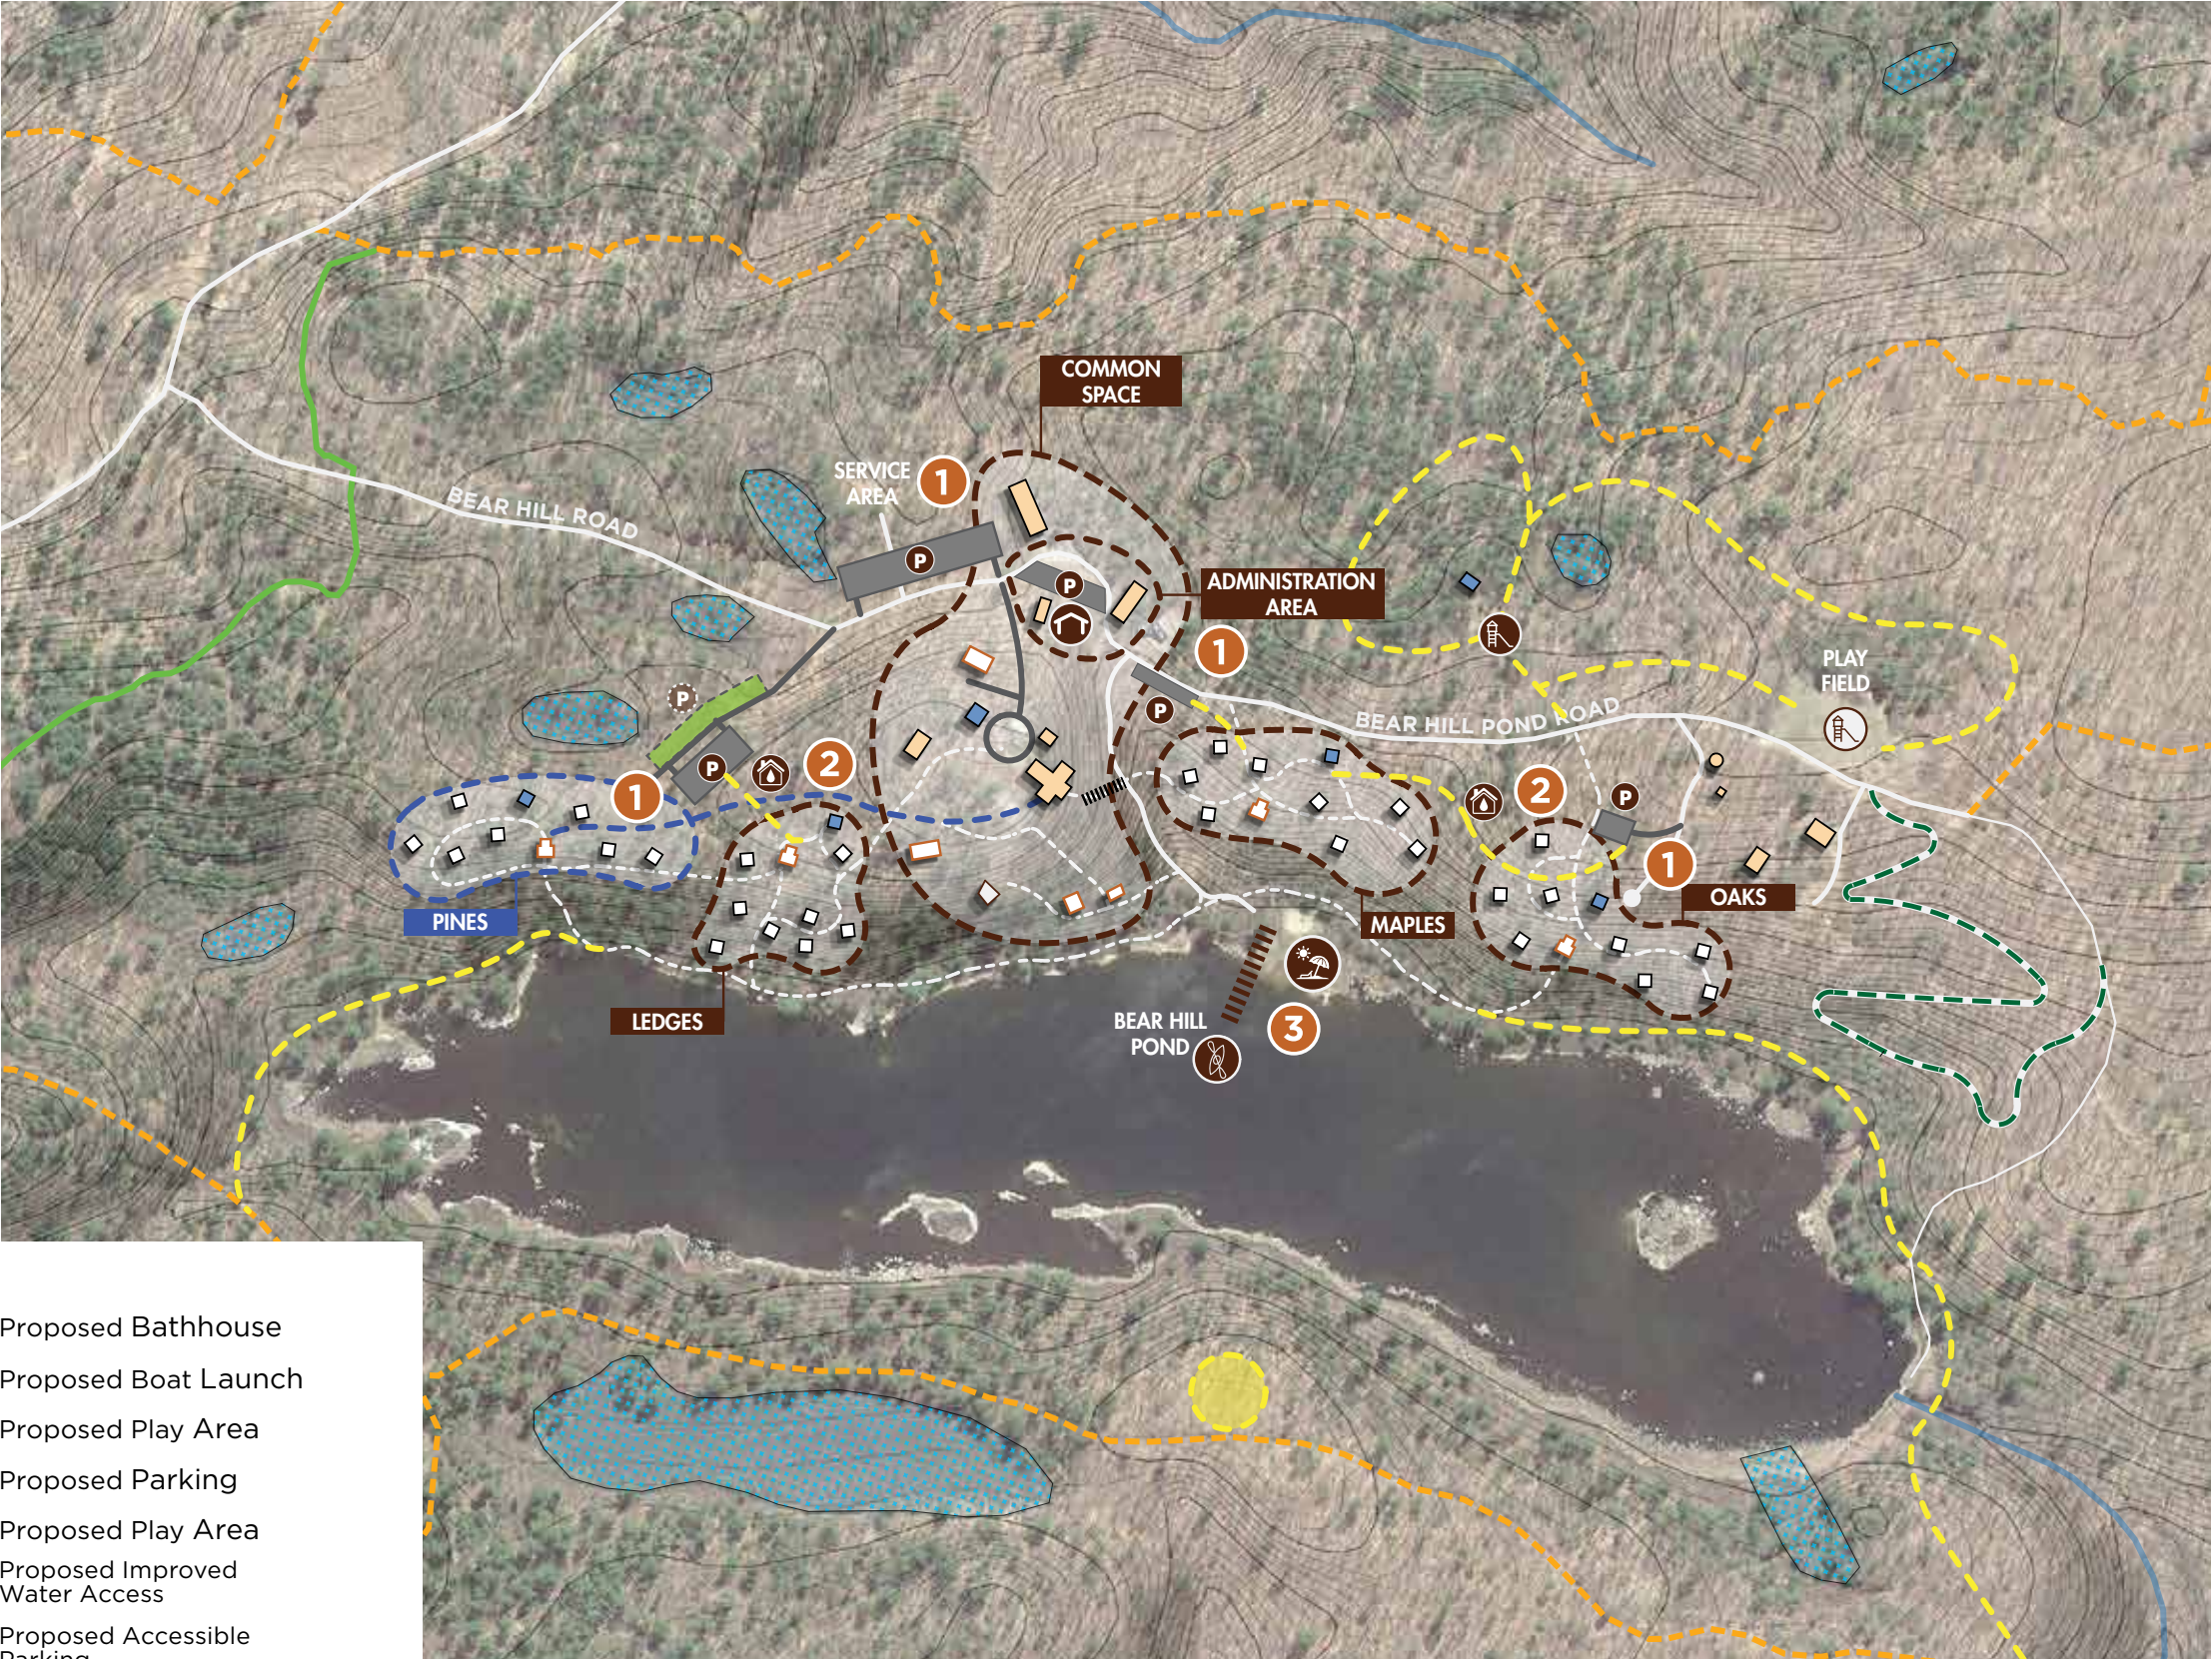
SITE PLAN  
CONTINUED

1. IMPROVED PARKING ACCESS
  - > Each pod will now have a dedicated parking area and new overflow parking areas for events
  - > Wagons could be used to help guests move their belongings to their cabins
2. ACCESSIBLE BATHHOUSES
  - > New bathhouses are proposed between the Pines and Ledges, and also between Maples and Oaks
3. NEW DOCK AT BEACH
  - > A new dock at the beach will help create a sense of place and allow for improved water access
