FINAL REPORT

Proposed Improvements for the Mt. Sunapee State Park Base Area

Department of Resources and Economic Development

Prepared by
The Cavendish Partnership
Dufresne-Henry

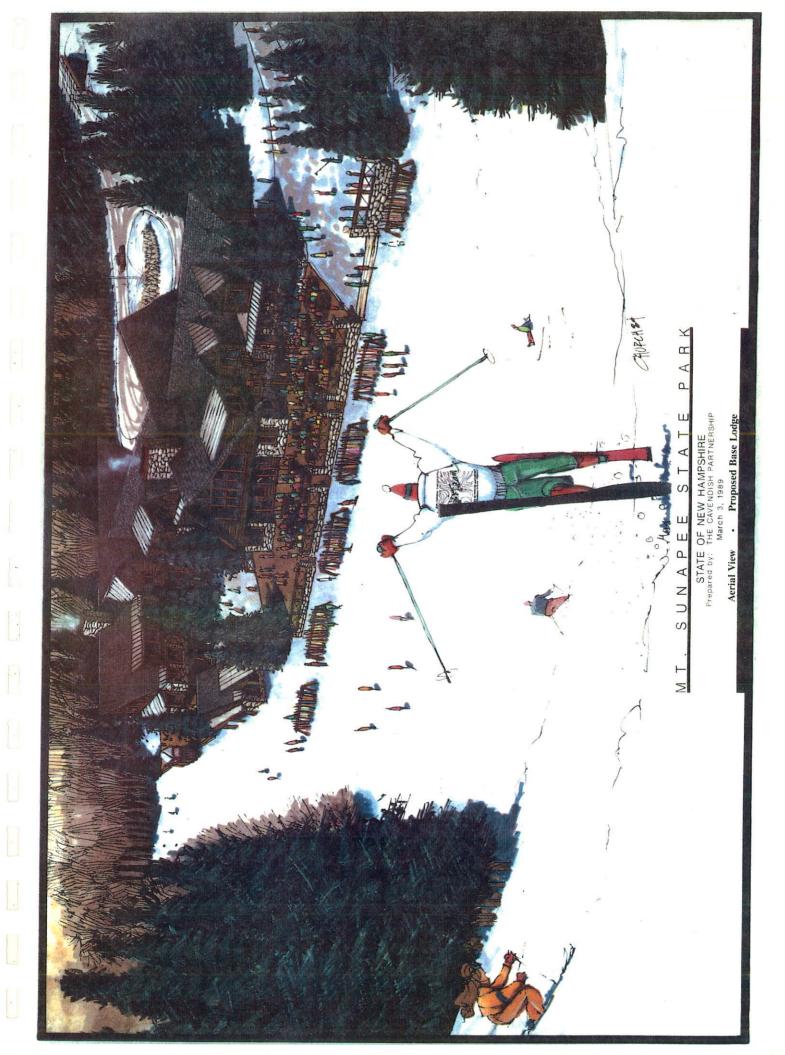
MAIN FLOOR PLAN

Mt. Sunapee State Park New Base Lodge
